# Automotive Engine Valve Recession

R Lewis and R S Dwyer-Joyce

Professional Engineering Publishing Limited,  
London and Bury St Edmunds, UK

First published 2002

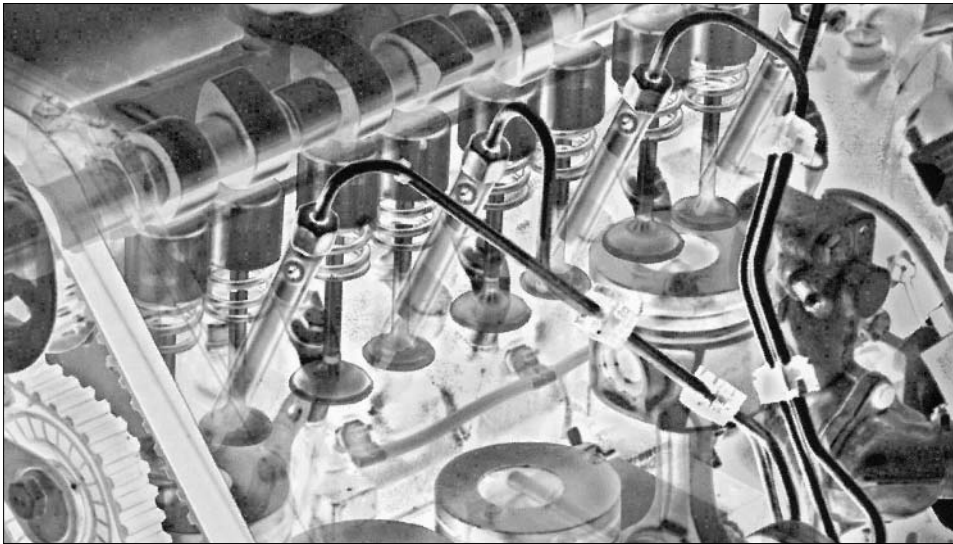
Valves (shown in-situ in an engine in Fig. 1.1) are used to control gas flow to and from cylinders in automotive internal combustion engines. The most common type of valve used is the poppet valve (shown in Fig. 1.2 with its immediate attachments). The valve itself consists of a disc-shaped head having a stem extending from its centre at one side. The edge of the head on the side nearest the stem is accurately ground at an angle – usually 45 degrees, but sometimes 30 degrees, to form the seating face. When the valve is closed, the face is pressed in contact with a similarly ground seat. It is the contact conditions and loading at this interface that will have the largest influence on the rate at which valve and seat wear will occur, so understanding these is a key in determining the mechanisms that cause valve recession.

**Fig. 1.1 Overhead camshaft valve drive**

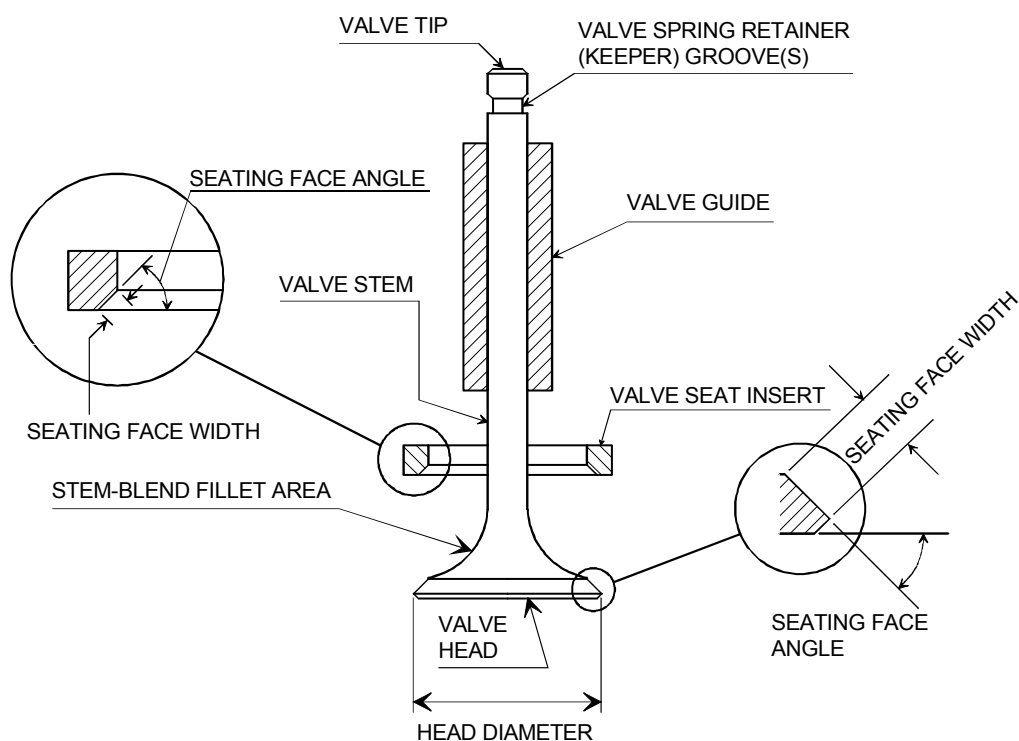
**Fig. 1.2 Valve and seat insert**

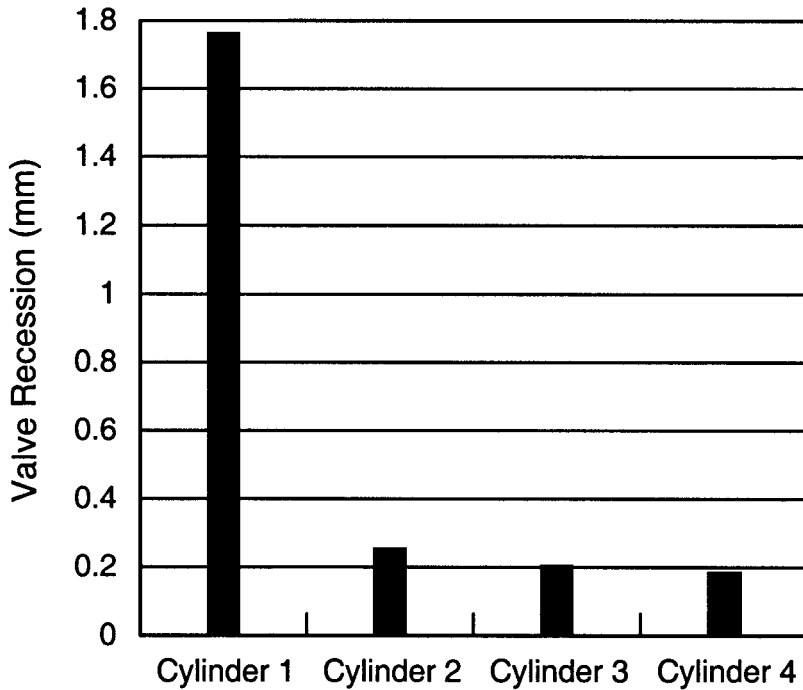
The impending reductions in the sulphur content of diesel fuel and the introduction of alternative fuels, such as gas, will also have implications for valve and seat insert wear. Dynamometer engine testing is often employed to investigate valve wear problems. This is expensive and time consuming, and does not necessarily help in finding the actual cause of the wear. Valve wear involves so many variables that it is impossible to confirm precise, individual quantitative evaluations of all of them during such testing. In addition, the understanding of wear mechanisms is complicated by inconsistent patterns of valve failure. For example, failure may occur in only a single valve operating in a multi-valve cylinder. Furthermore, the apparent mode of failure may vary from one valve to another in the same cylinder or between cylinders in the same engine. An example of such inconsistency is shown in Fig. 1.3. This illustrates exhaust valve recession values for four cylinders in the same engine (measurements taken on the cylinder head). The valve in cylinder 1 has recessed to the point where pressure is being lost from the cylinder, while the other valves have hardly recessed at all.

**Fig. 1.3 Recession measurements for exhaust valves in the same 2.5 litre diesel engine cylinder head**

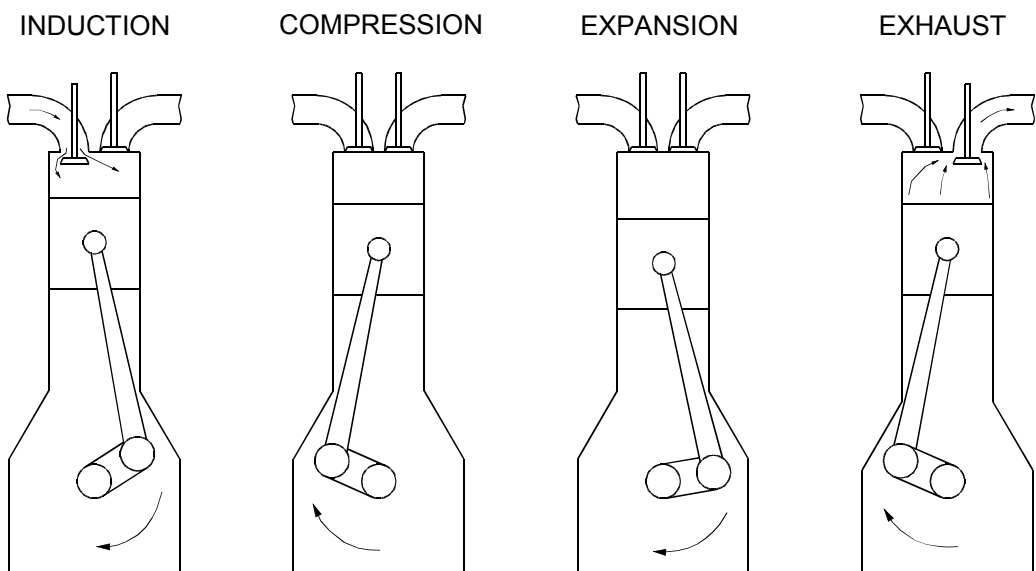
Both types of engine can be designed to operate in either two strokes of the piston or four strokes of the piston. The four-stroke operating cycle can be explained by reference to Fig. 2.1. This details the position of the piston and valves during each of the four strokes.

Fig. 2.1 Four-stroke engine cycle

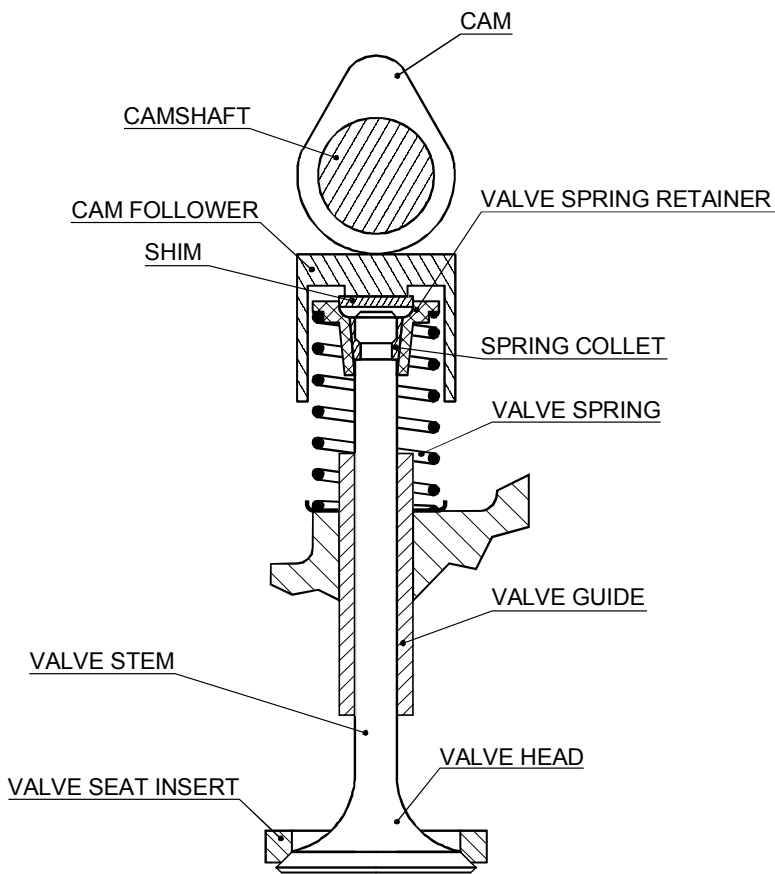
In the system shown in Fig. 2.3 the camshaft operates on a follower or bucket. The clearance between the valve tip and the follower is adjusted by a shim. This is more difficult to adjust than in systems using rockers, but is less likely to change. The spring retainer is attached to the valve using a tapered split collet. The valve guides are usually press-fitted into the cylinder head, so that they can be replaced when worn. Valve seat inserts are used to ensure minimal wear. The valves rotate in order to ensure even wear and to maintain good seating. This rotation is promoted by having the cam offset from the valve stem axis. This also helps to avoid localized wear on the cam follower.

**Fig. 2.3 Overhead camshaft valve drive**

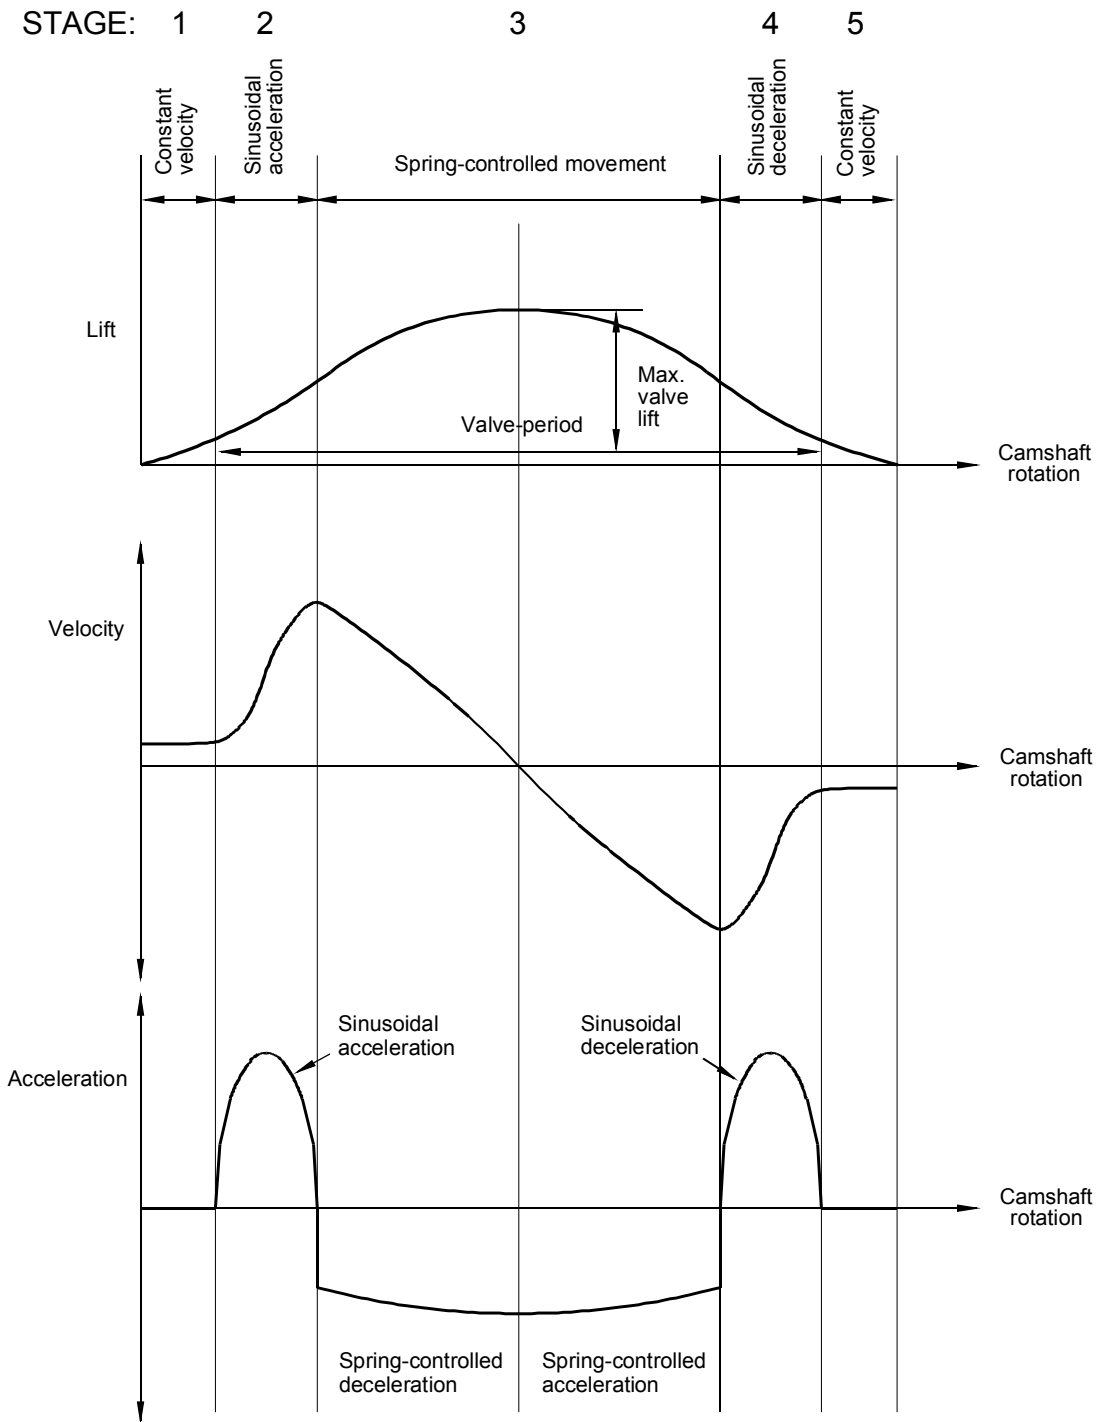
Figure 2.4 [1] shows theoretical valve lift, velocity, and acceleration. The motion can be split into five stages.

Fig. 2.4 Theoretical valve motion [1]

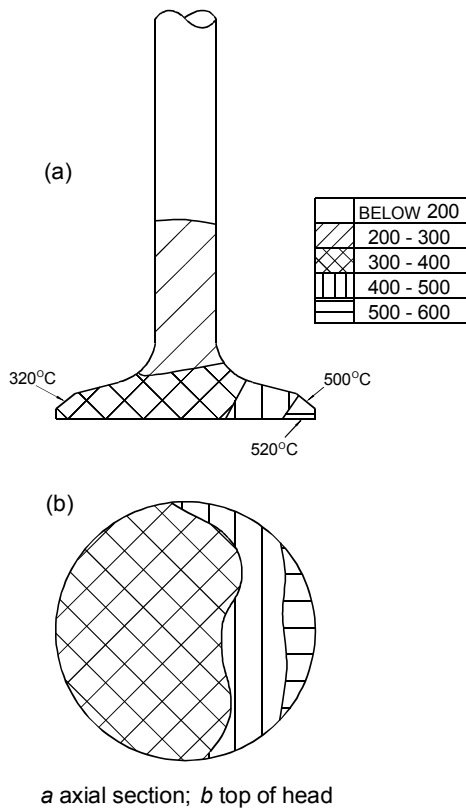
**Fig. 2.9 Typical inlet valve temperature distribution [3]**

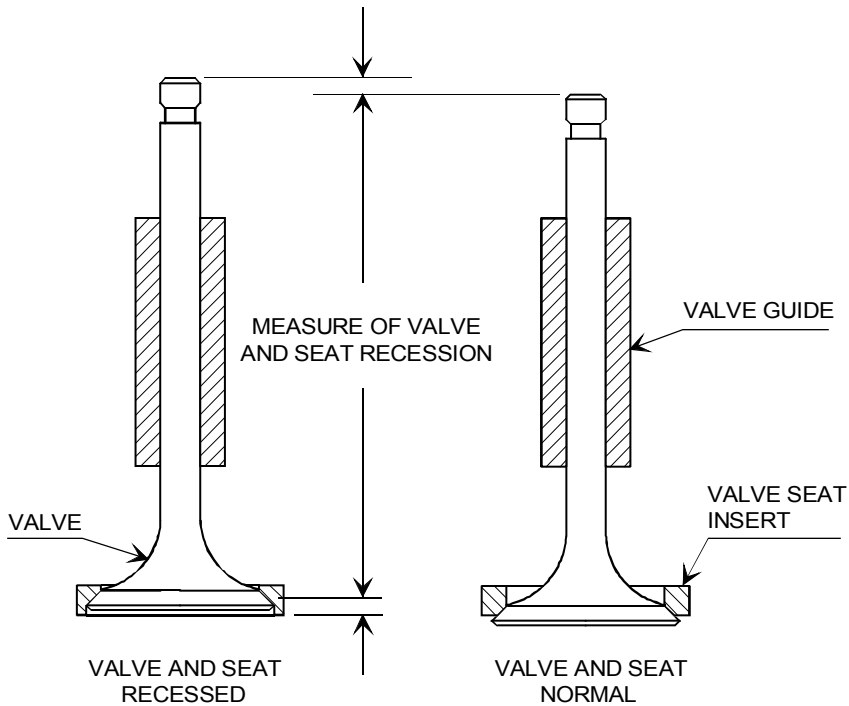
Engines are typically designed to tolerate a certain amount of valve recession. After this has been exceeded, the gap between the valve tip and the follower must be adjusted to ensure that the valve continues to seat correctly. If the valve is not able to seat, cylinder pressure will be lost and the hot combustion gases that leak will cause valve guttering or torching to occur, which will rapidly lead to valve failure.

Fig. 3.1 Valve recession

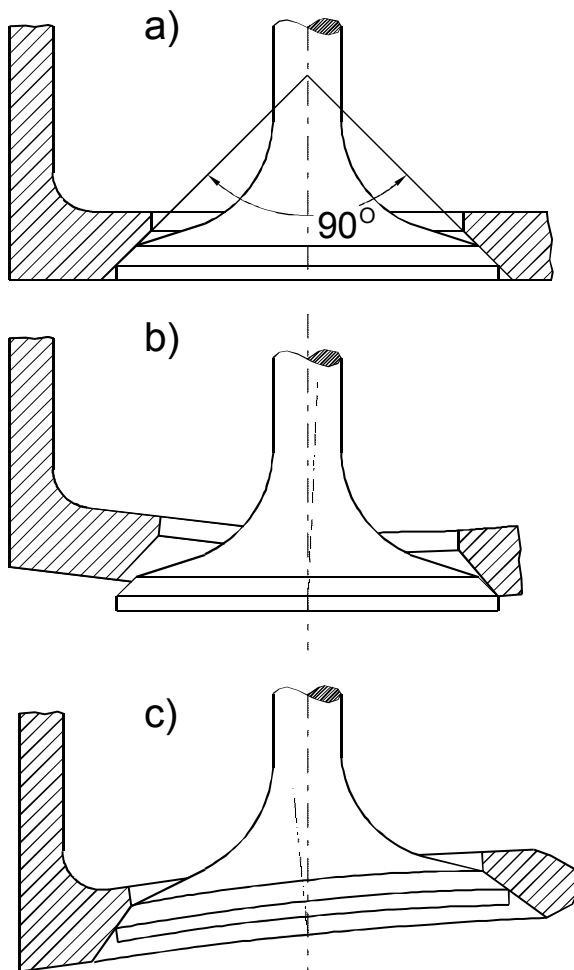
Figure 3.2 diagrammatically represents the effect of thermal distortions in the cylinder head. Figure 3.2(a) shows a valve not subjected to pressure on a non-deformed seat insert in a position flush with the cylinder head. The assumption in Fig. 3.2(b) is that the cylinder head has been deformed due to uneven temperatures and the valve, being under no load, projects slightly from its seat insert and makes only one-sided contact. Figure 3.2(c) shows the valve forced into its seat by the gas pressure, which implies the existence of sliding motion.

**Fig. 3.2 Deformation of a cylinder head bottom and valve: (a) valve with 45 degree seat angle in plane cylinder head bottom; (b) downward bottom deflection; valve making one-sided contact; (c) bottom deflected upwards and valve disc bent under influence of gas pressure [3]**

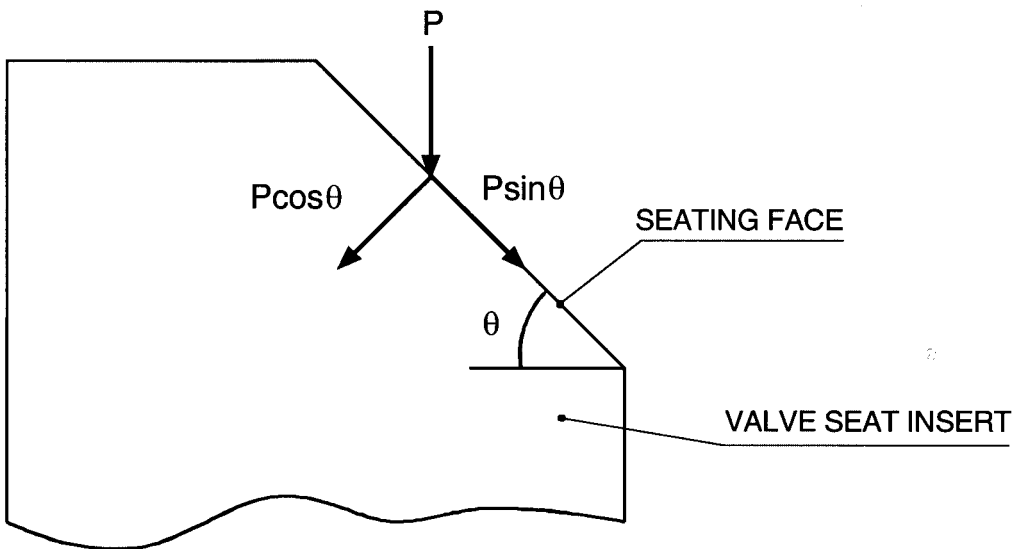
It was suggested that if the  $P\sin\theta$  component exceeds the shear stress of the seat insert material, plastic shear deformation of the surface material may be induced. This could lead to crack formation and eventually, after repeated loading, to particles of material (asperities) breaking away from the surface. The wear debris may either be blown off by gas flow when the valve opens or remain on the seating surface and:

**Fig. 3.3 Forces acting on a seat insert seating face [5]**

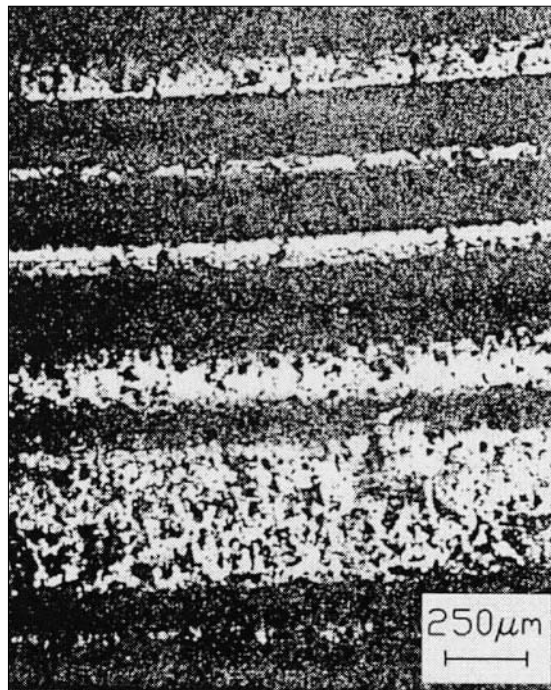
Van Dissel *et al.* [7] observed distinct trenches on the seating faces of recessed valves where seating occurred. Seat recession varied from negligible to 0.56 mm. Worn regions typically exhibited unique topographic features. Pitting, gouging, and indentation of the seating face were all observed. One feature common to most recessed valves was observed. This was a series of ridges and valleys formed circumferentially around the axis of the seating face. In some cases the ridges and valleys were concentric, as waves would appear if a single stone was dropped into a pool. This was described as a ‘single wave formation’ (see Fig. 3.4). In other cases the ridges and valleys overlapped each other, as waves would appear if several stones were dropped into a pool. This was described as a ‘multiple wave formation’ (see Fig. 3.5). Ridge formation was found to vary according to engine type.

**Fig. 3.4 Inlet valve seating face showing ‘single wave ridge formation’ (Major diameter is towards the bottom) [7]**

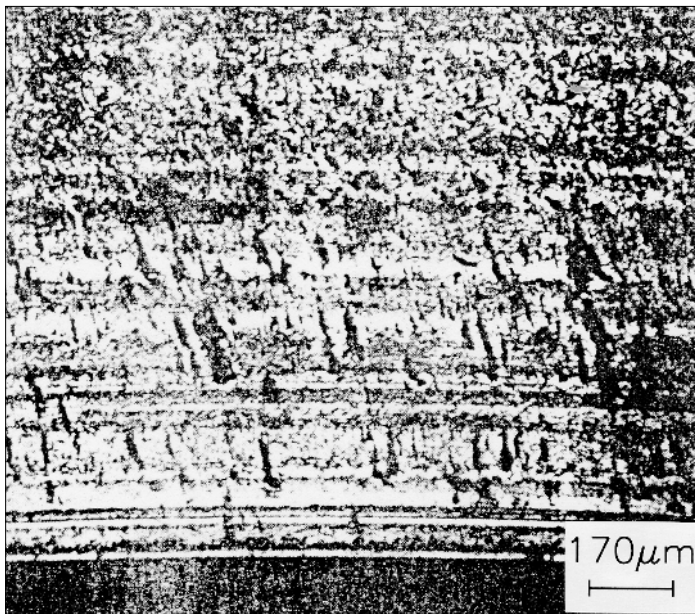
Wear of seat inserts ranged from negligible to moderate. The material removal process resulted in a concave seating face configuration. Radial scratches were observed within the concave region, as shown in Fig. 3.6.

**Fig. 3.6 Pitting of inlet seat insert (Major diameter is towards the top) [7]**

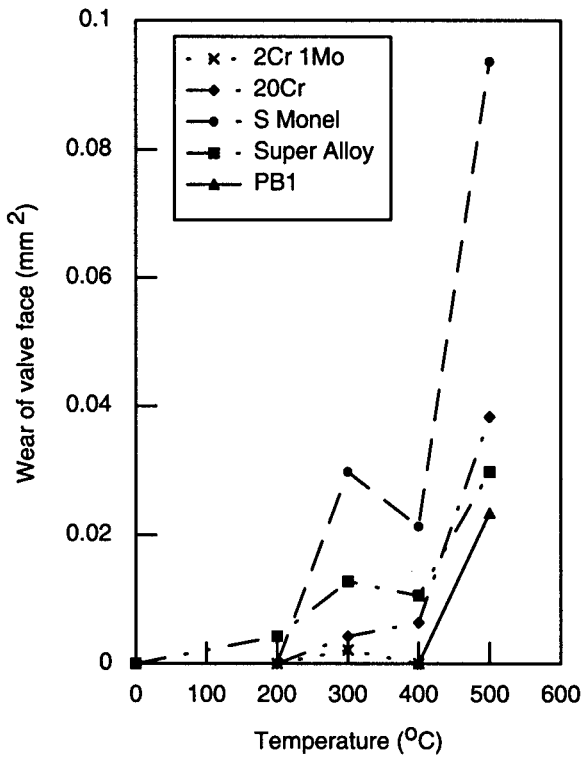
Fig. 3.8 Wear of Stellite valve faces when mated with various seat inserts [18]

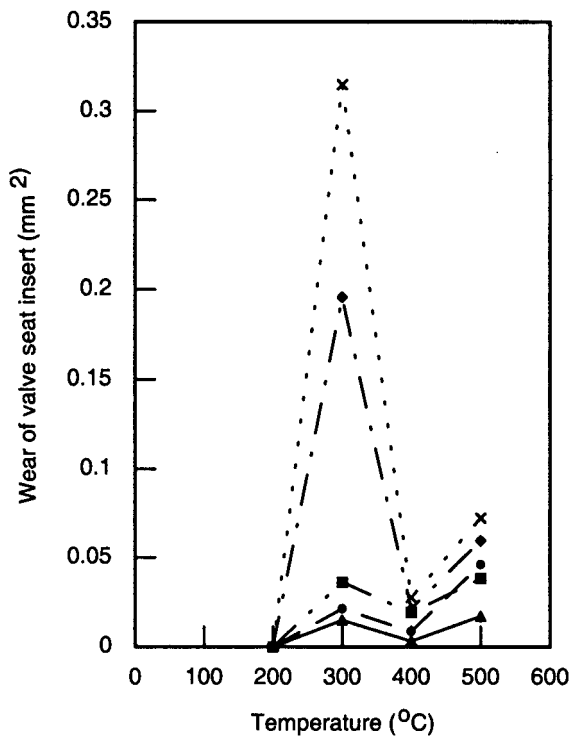
Fig. 3.9 Wear of various seat inserts when mated with Stellite valves [18]

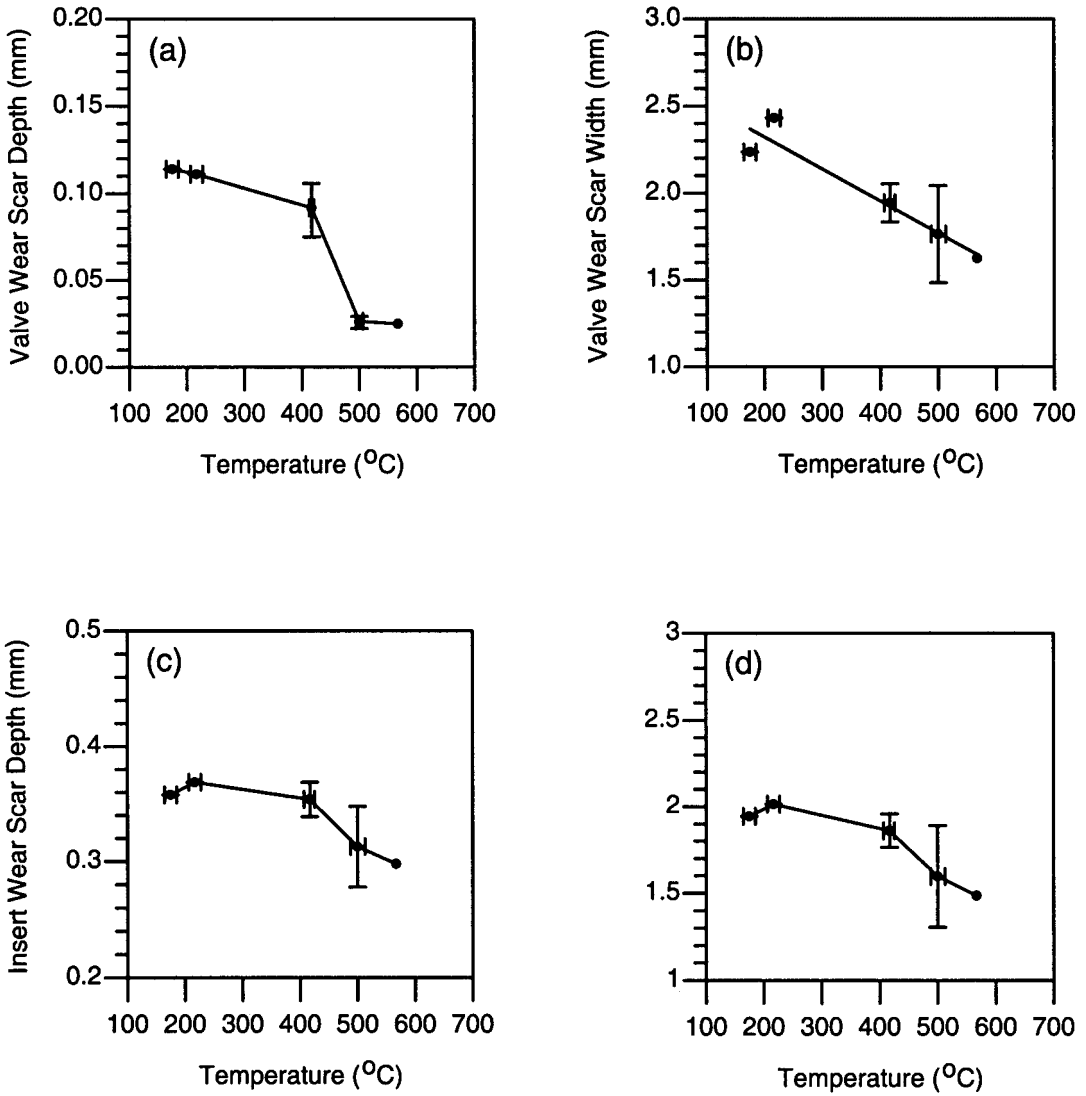
**Fig. 3.10 Seating face wear as a function of temperature: (a) valve seating face scar depth; (b) valve seating face scar width; (c) seat insert seating face scar depth; (d) seat insert seating face scar width [20]**

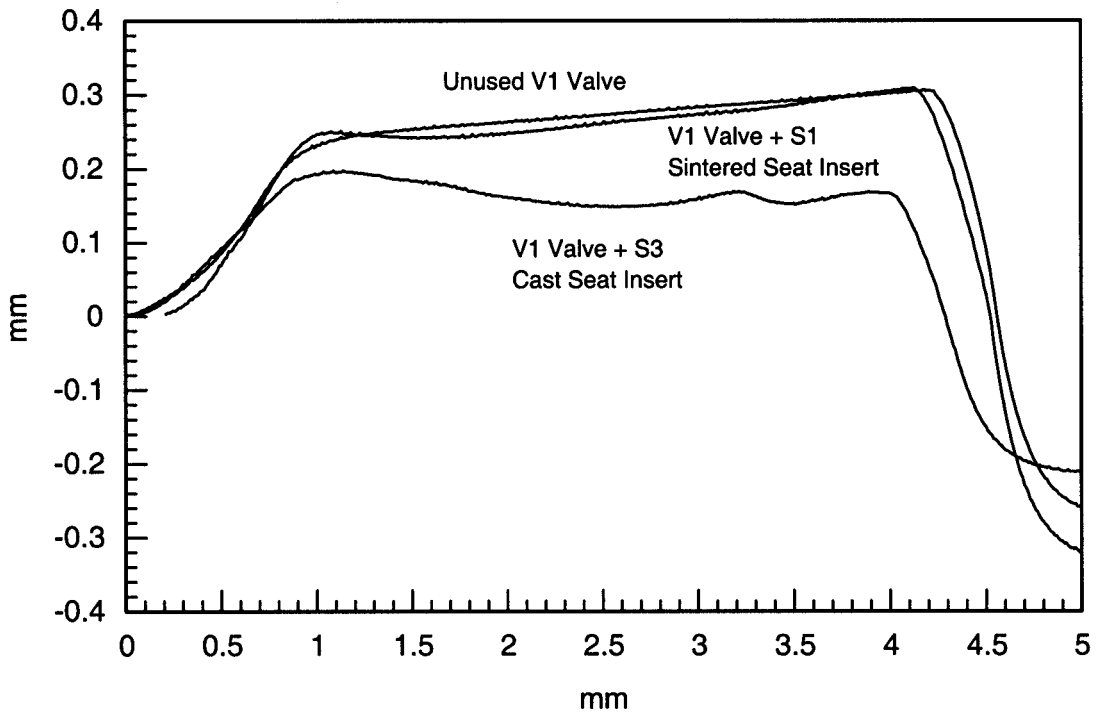
Fig. 4.2 Inlet valve profile traces

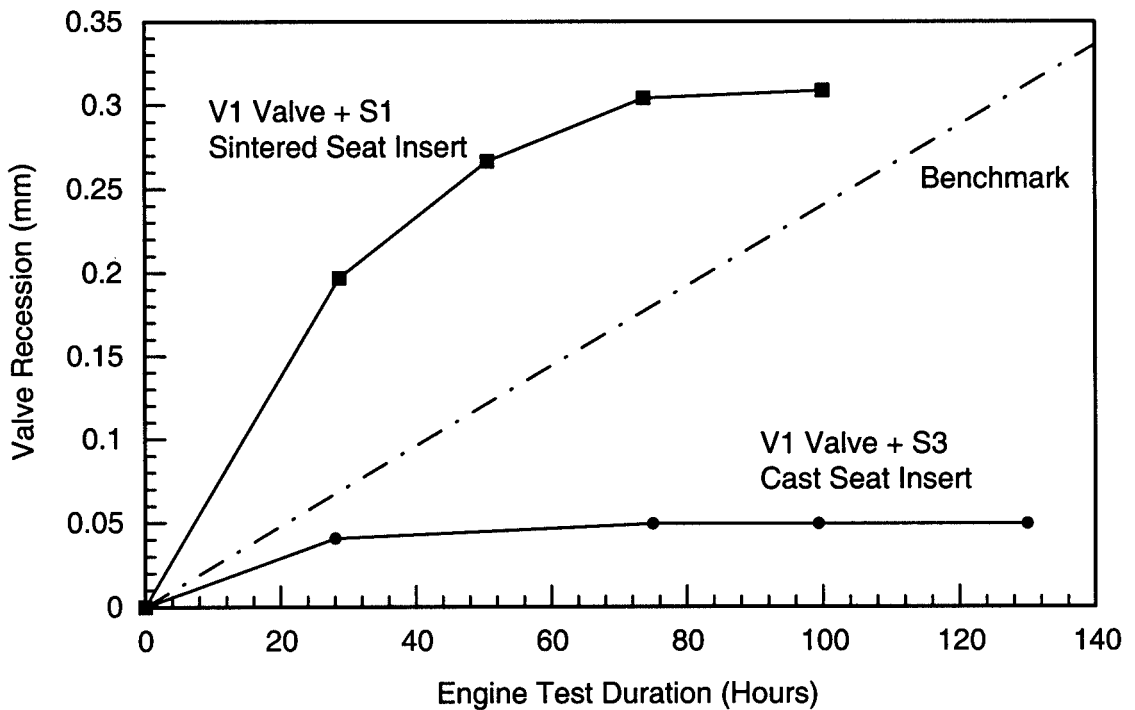
Fig. 4.4 Valve clearance data from engine dyno tests

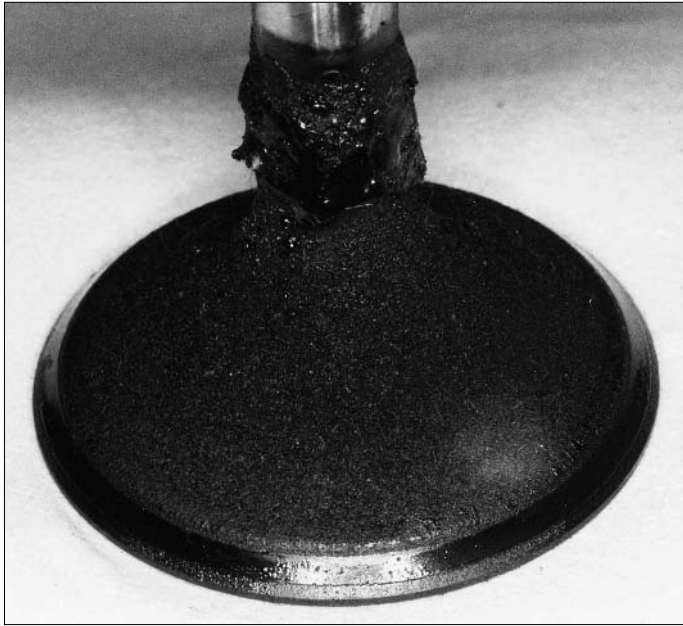
**Fig. 4.5 Inlet valve (valve material V1 run against insert material S3)**

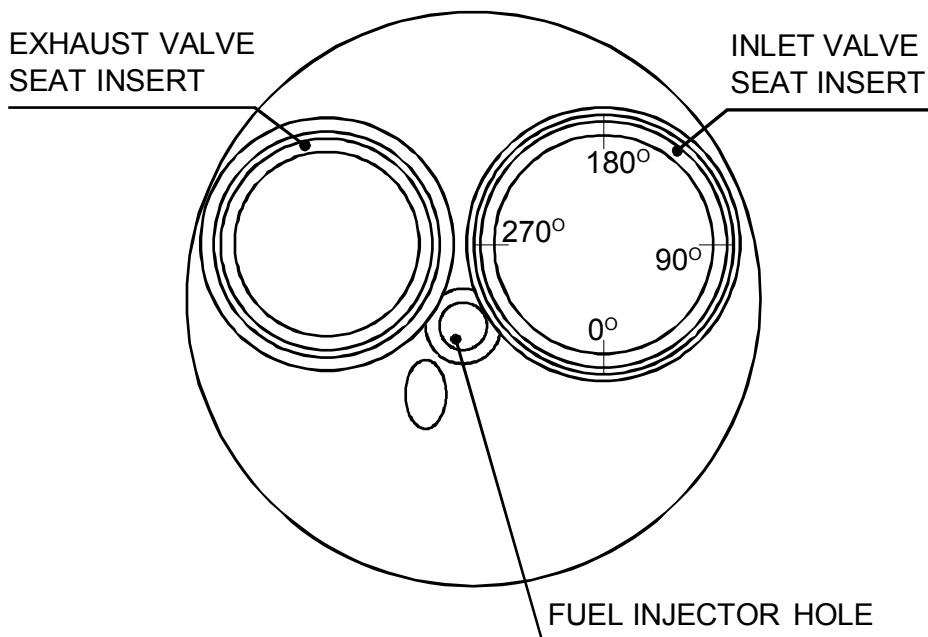
**Fig. 4.11 Position of profiles taken on 1.8 l DI inlet seat insert**

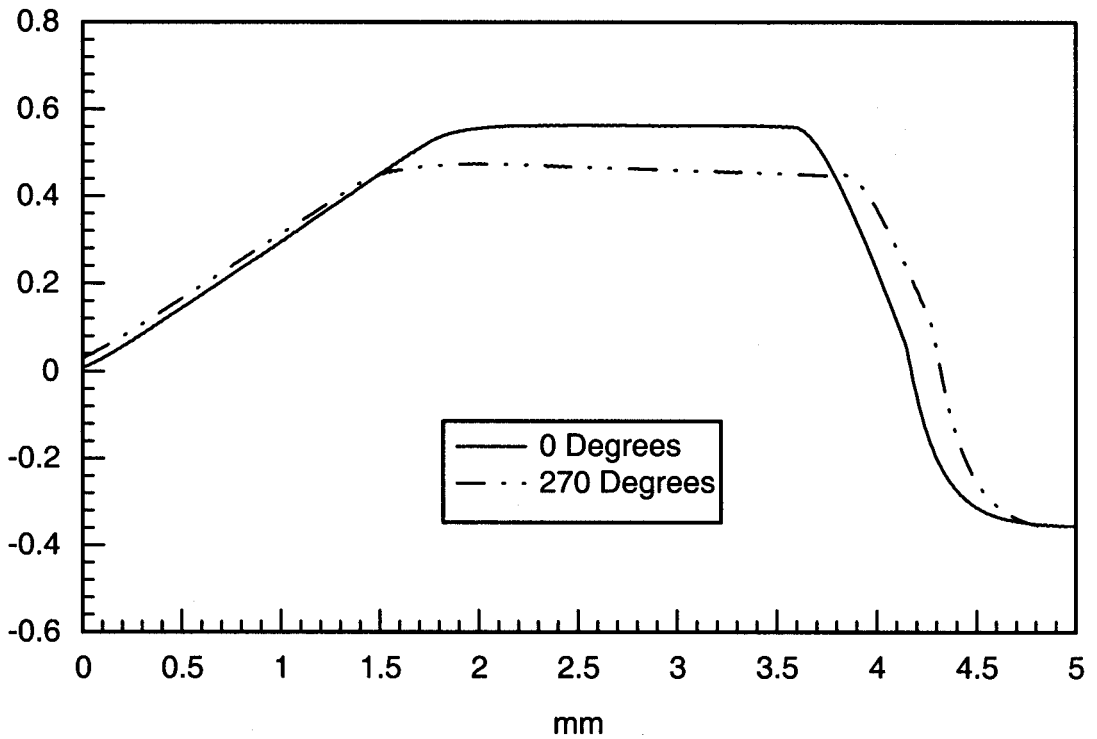
Fig. 4.12 Profile traces taken on 1.8 l DI inlet seat insert

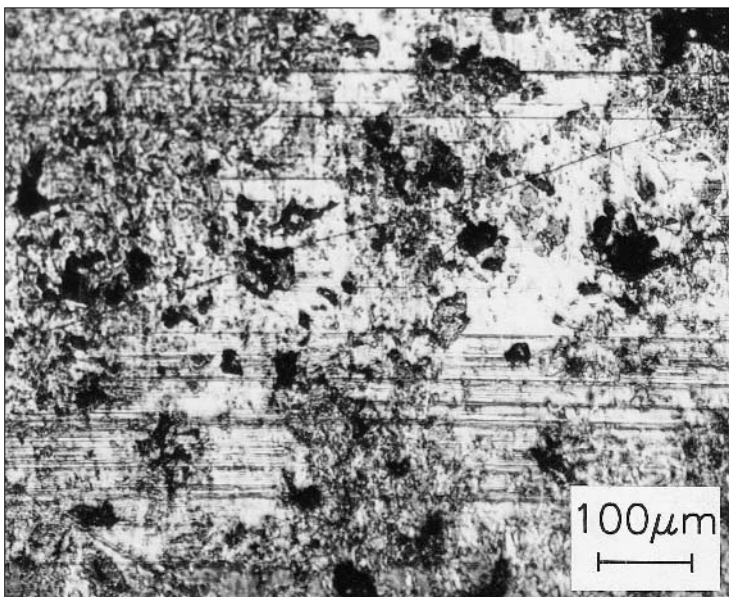
**Fig. 4.14 A 1.8 l DI inlet seat insert seating face (valve material V1 run against seat insert material S3 in a high-speed engine test); major seat diameter is towards top of figure**

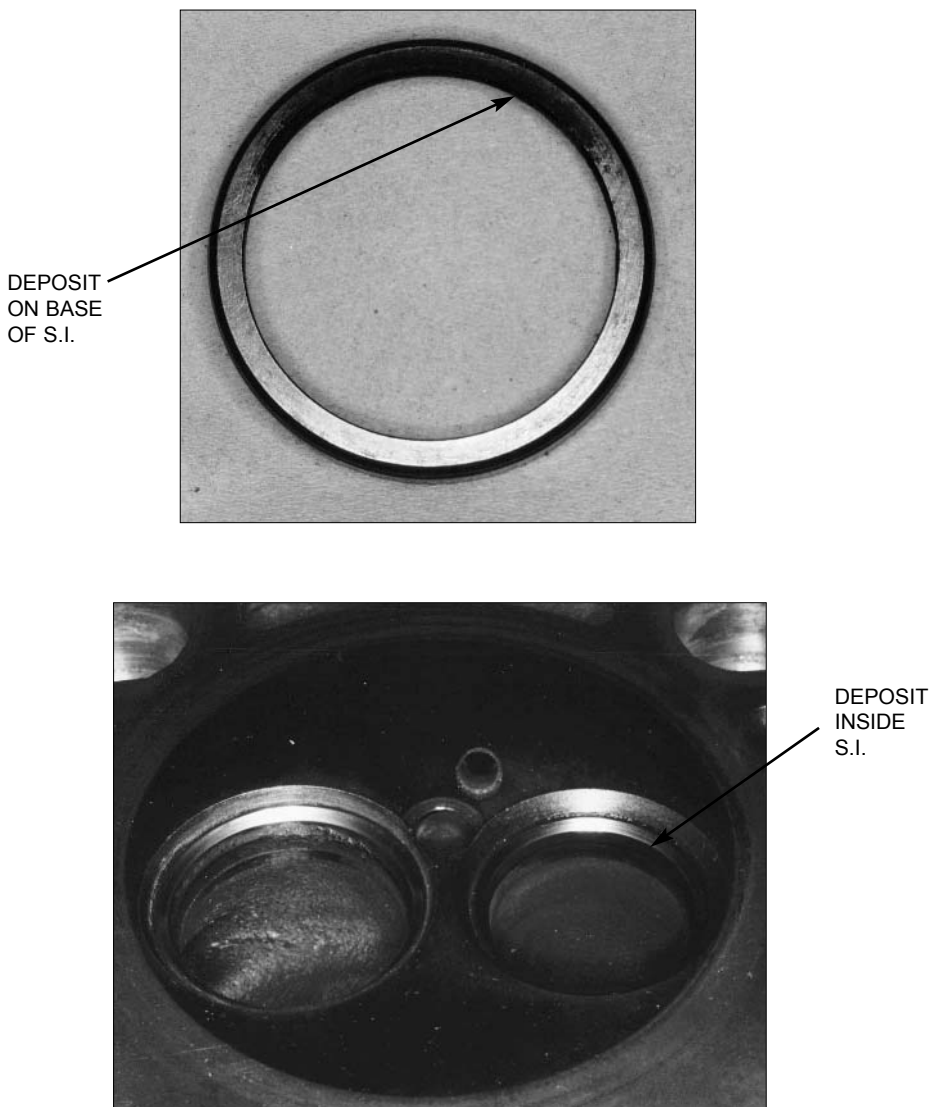
**Fig. 4.15** Deposit build-up on 1.8 l DI inlet seat insert

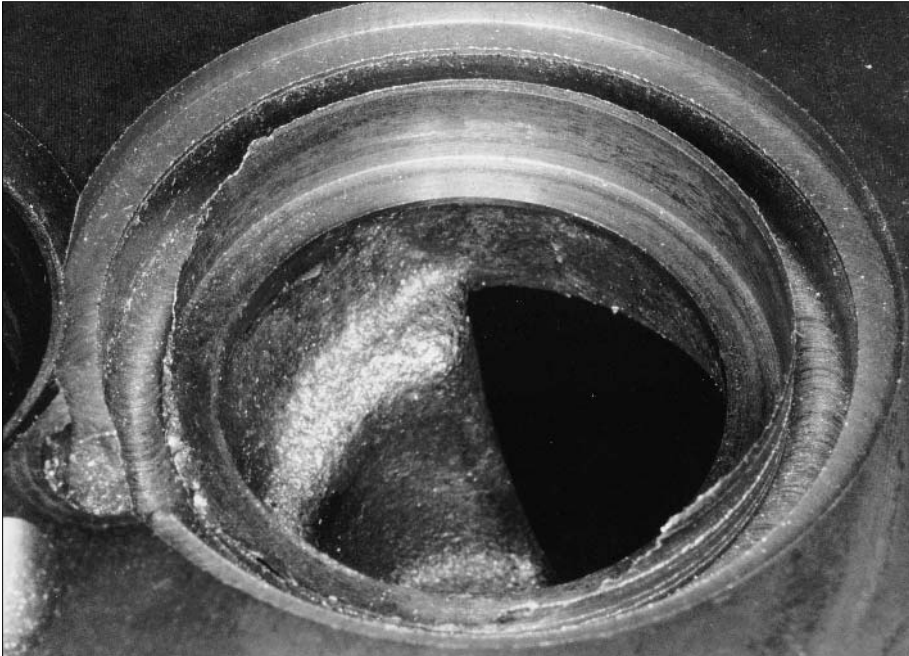
**Fig. 4.16 Evidence of seat insert misalignment relative to the valve guide (1.8 l DI)**

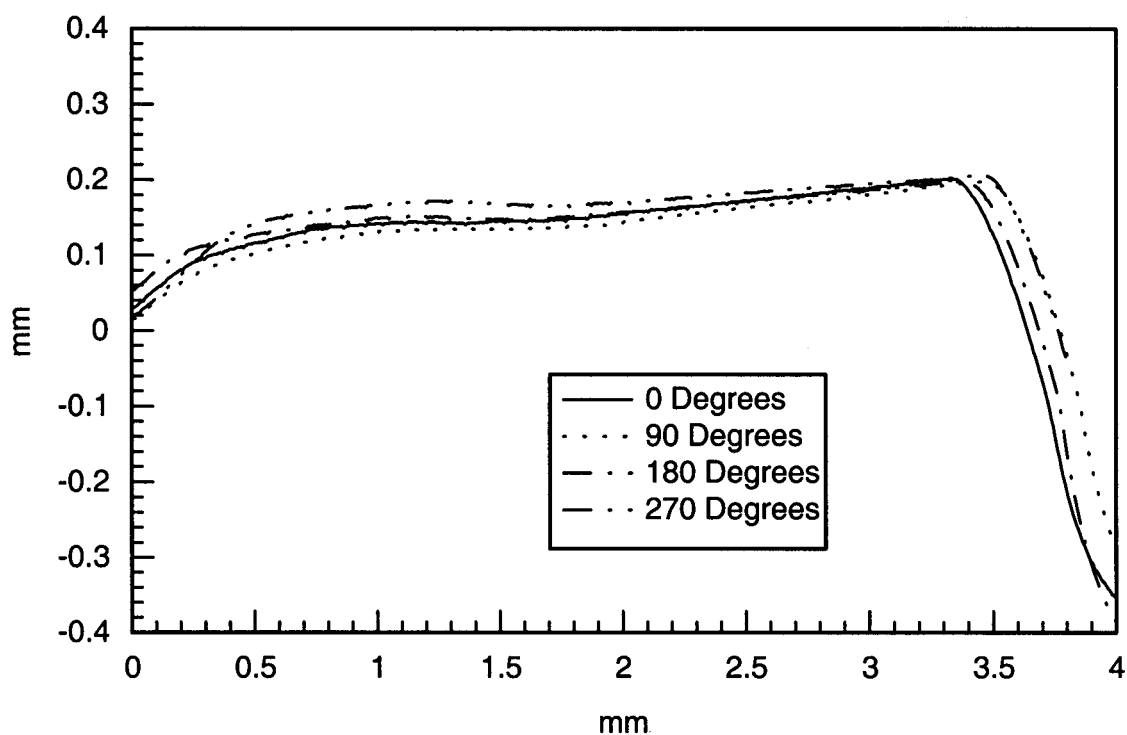
Fig. 4.17 Profile traces taken on 1.8 l DI inlet valve

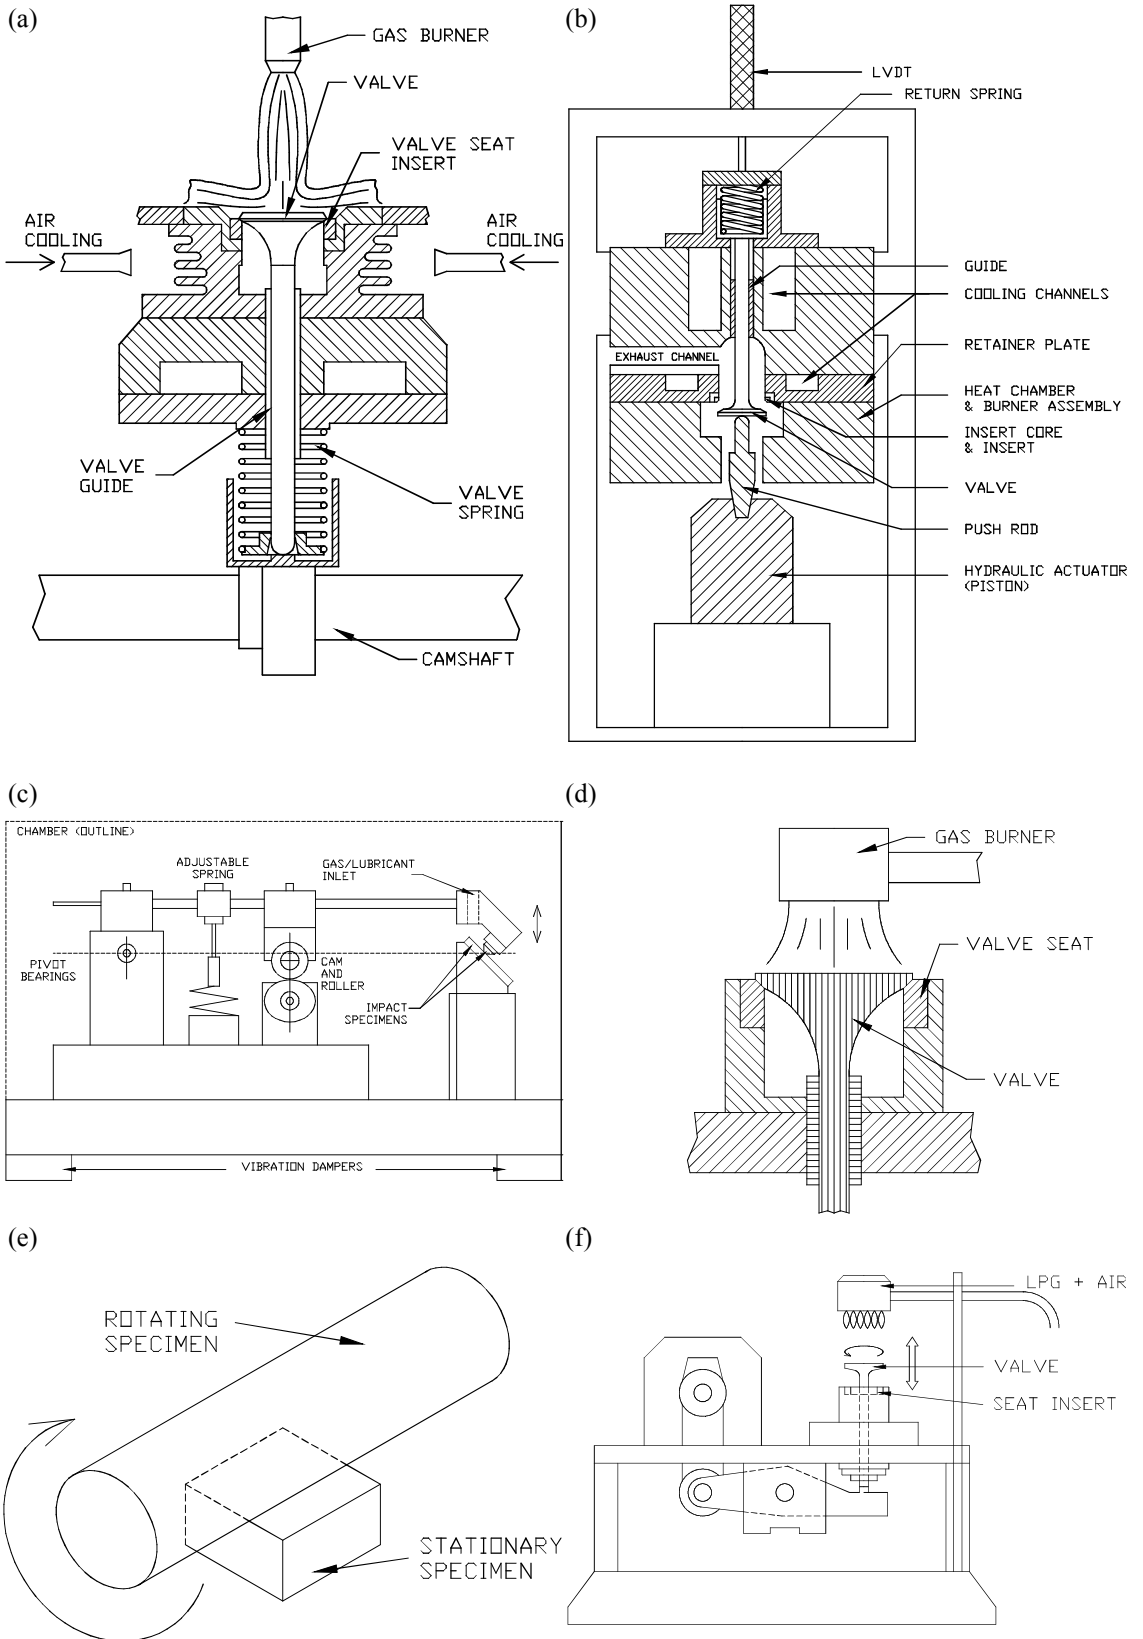
**Fig. 5.1** Examples of the test rigs reviewed: (a) Fujiki and Makoto [8]; (b) Malatesta *et al.* [9]; (c) Blau [5]; (d) Nakagawa *et al.* [7]; (e) Hofmann *et al.* [6]; (f) Matsushima [4]

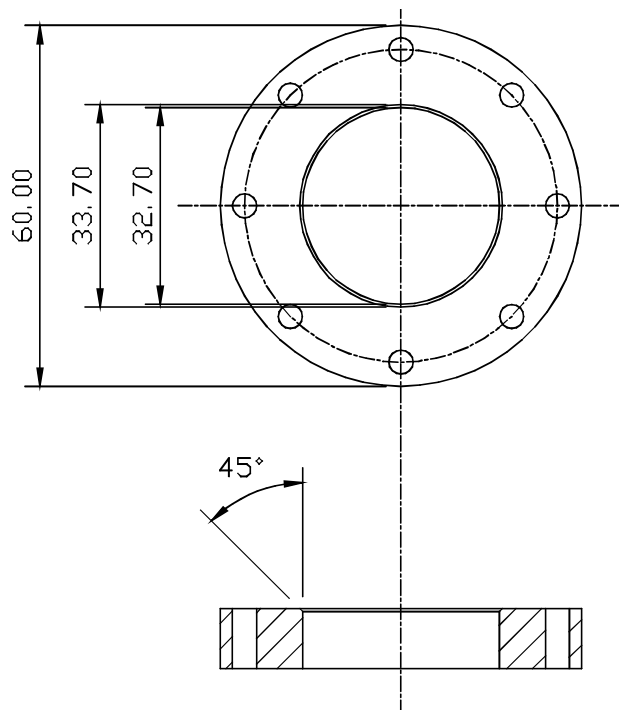
**Fig. 5.5 Seat specimen geometry**

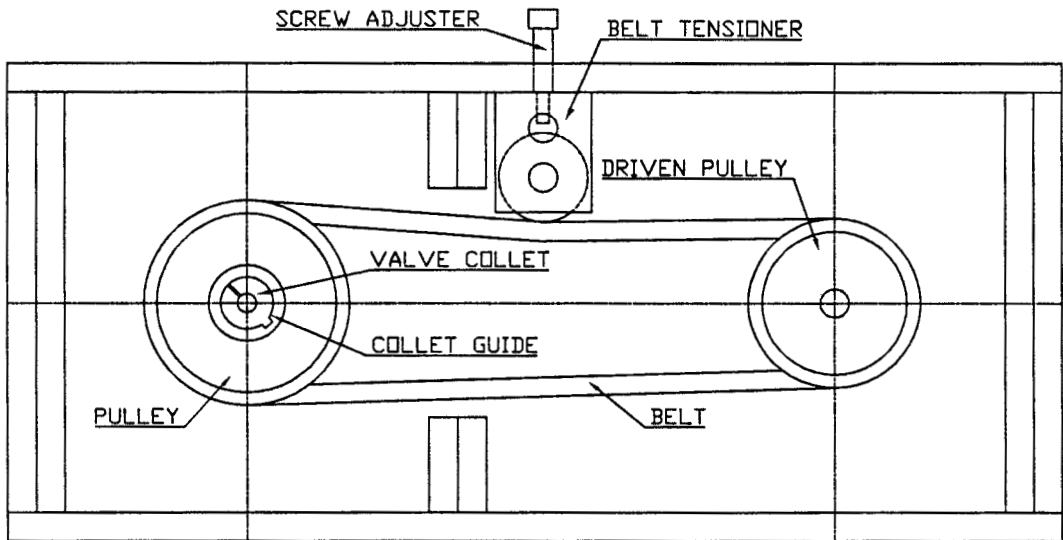
**Fig. 5.6 Plan view of valve rotation system**

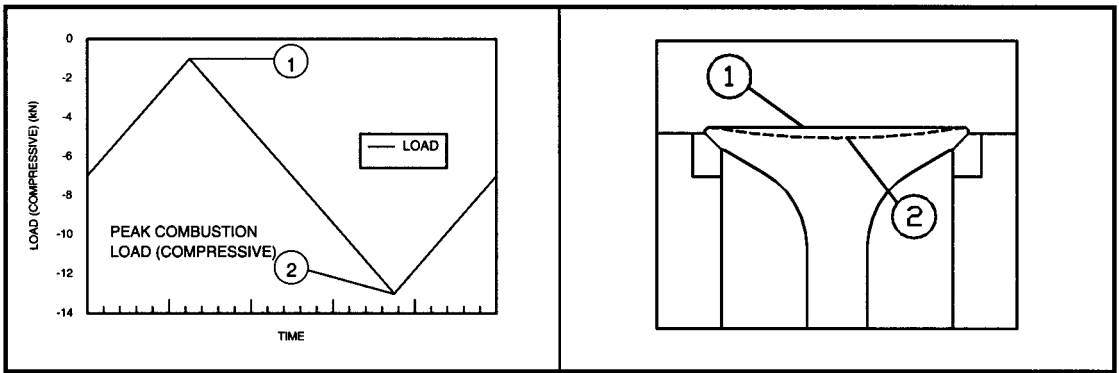
**Fig. 5.9 Frictional sliding test methodology**

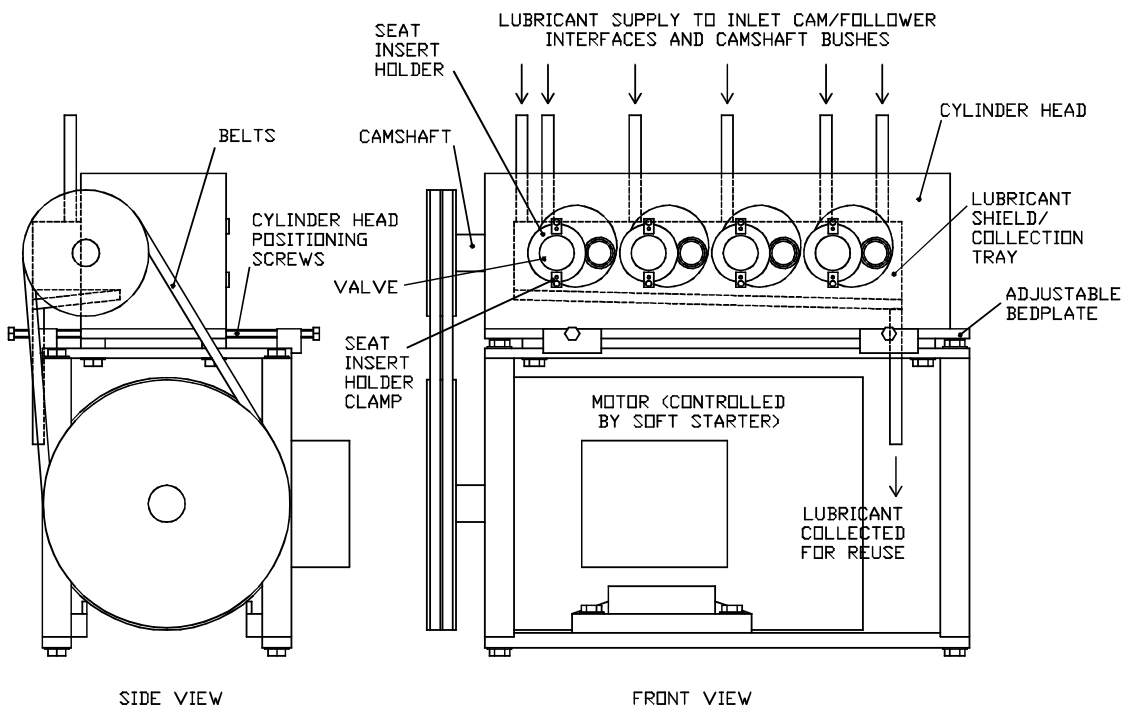
**Fig. 5.12 Motorized cylinder head**

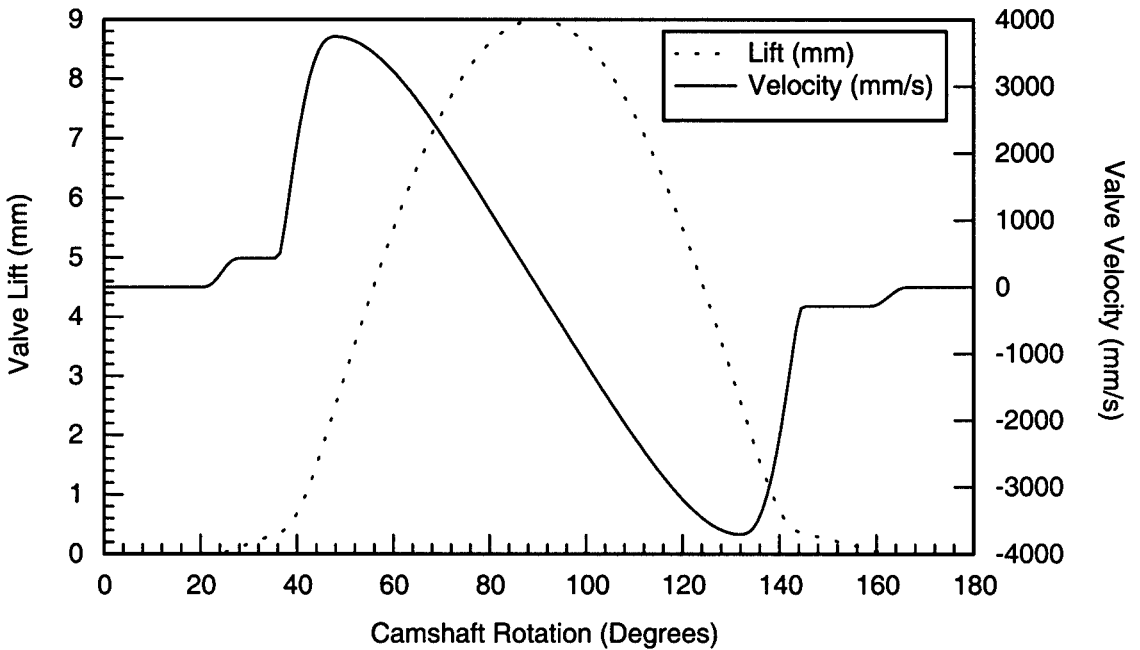
Fig. 5.14 1.8 l, IDI, diesel engine inlet valve lift and velocity
