# Automotive Engine Valve Recession

R Lewis and R S Dwyer-Joyce

Professional Engineering Publishing Limited,  
London and Bury St Edmunds, UK

First published 2002

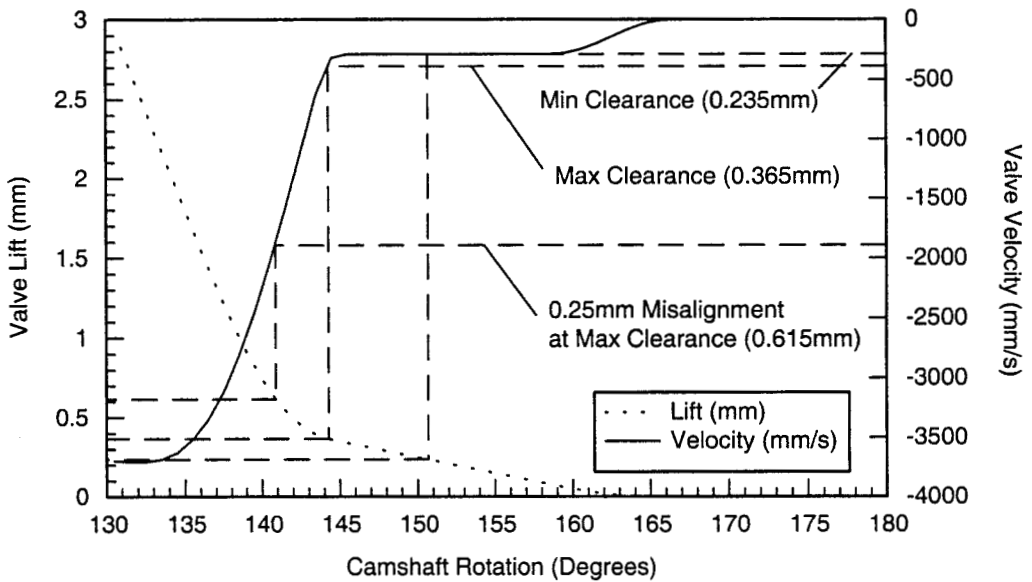
**Fig. 5.15 1.8 l, IDI, diesel engine inlet valve lift and velocity at valve closure**

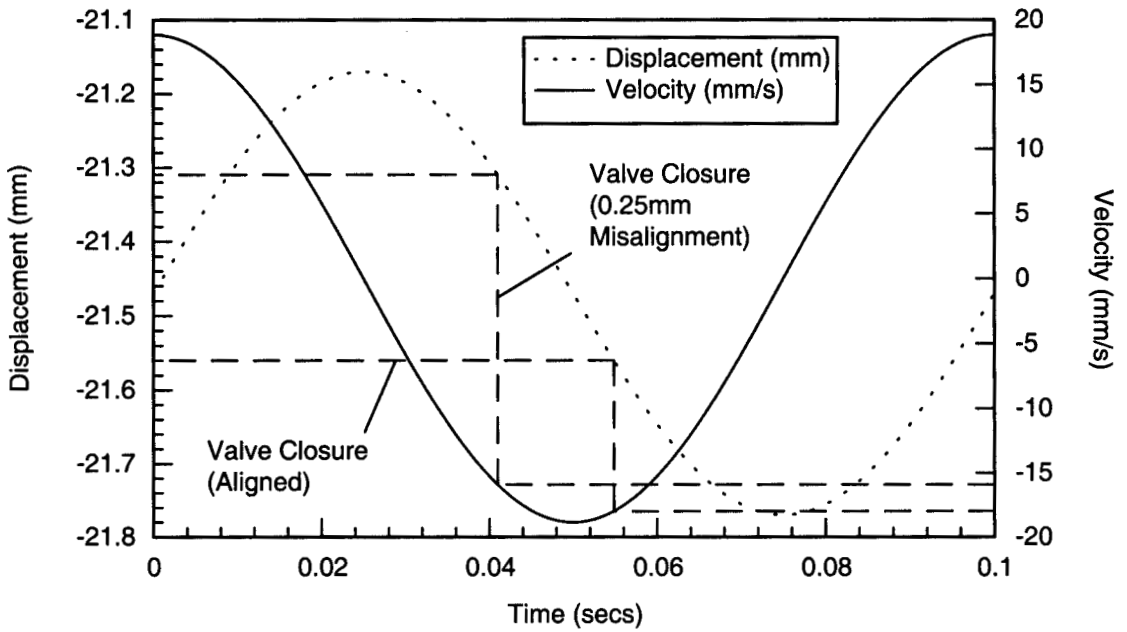
**Fig. 5.20 Test rig displacement and velocity in hydraulic test machine (13 kN combustion load)**

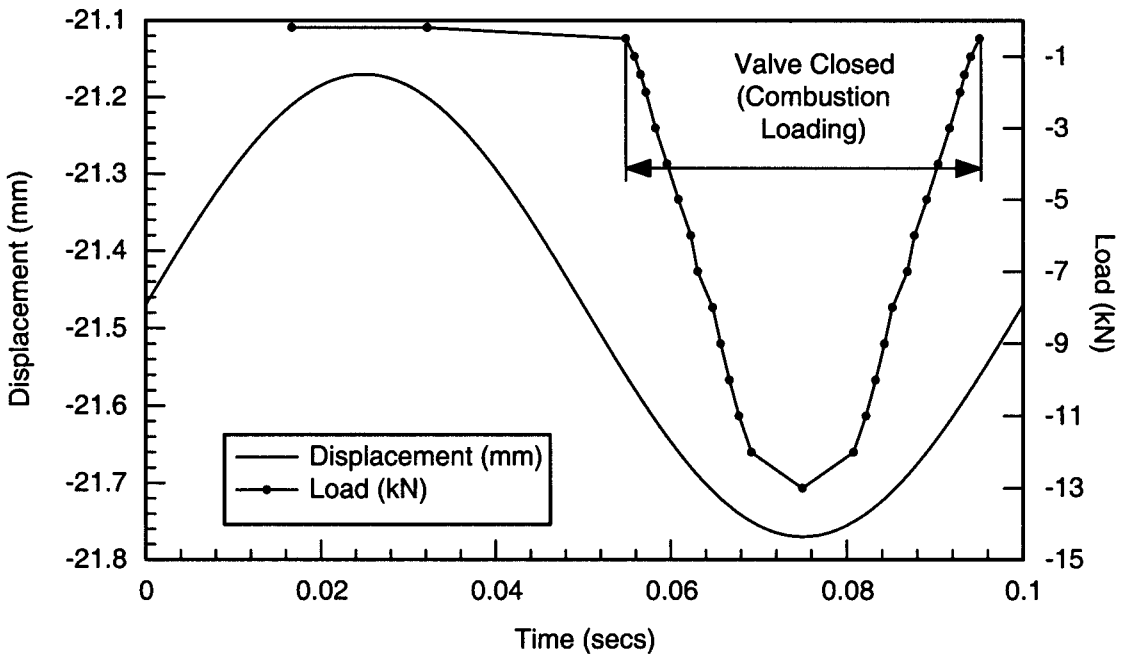
Fig. 5.22 Test rig displacement and actuator load

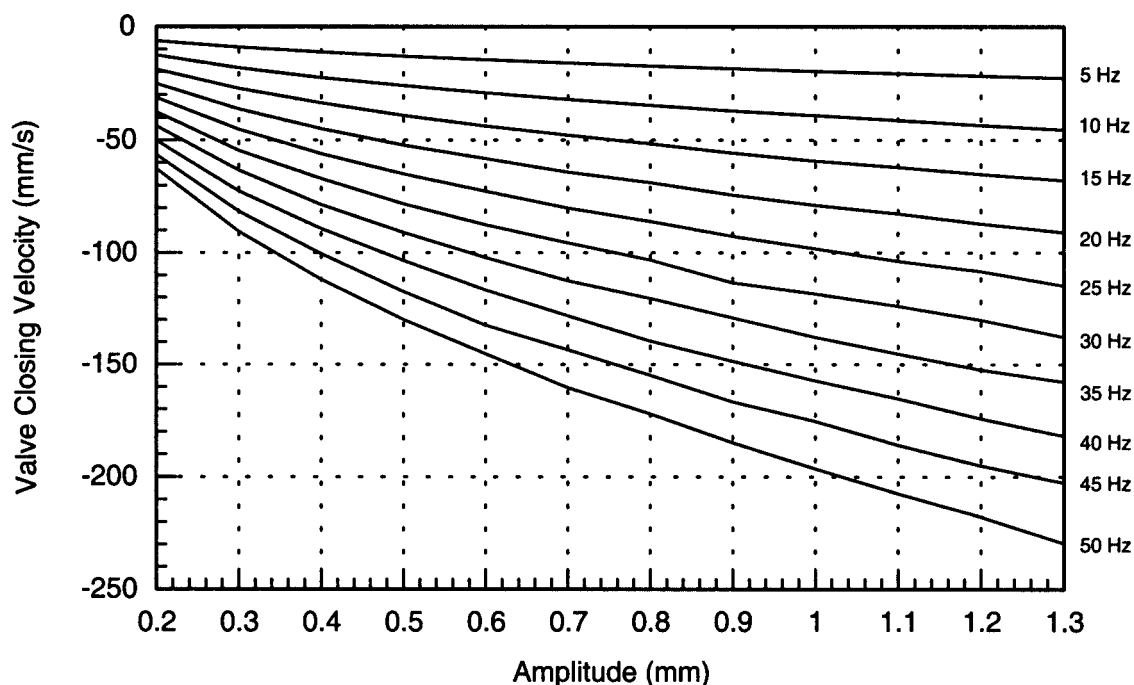
**Fig. 5.23 Valve closing velocity against amplitude for varying frequencies (13 kN combustion load)**

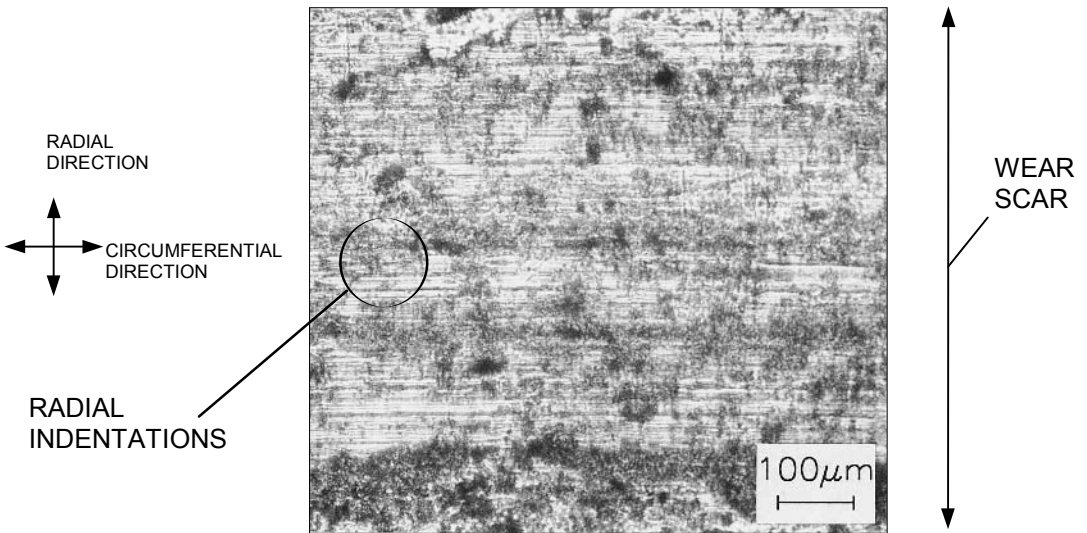
**Fig. 6.1** Seat insert seating face showing indentations in the radial direction (valve material V1 run against sintered seat insert material S1 on hydraulic loading apparatus). Major seat diameter is towards top of figure. See Table 6.1 for details of materials. (Reprinted with permission from SAE paper 1999-01-1216 © 1999 Society of Automotive Engineers, Inc.)

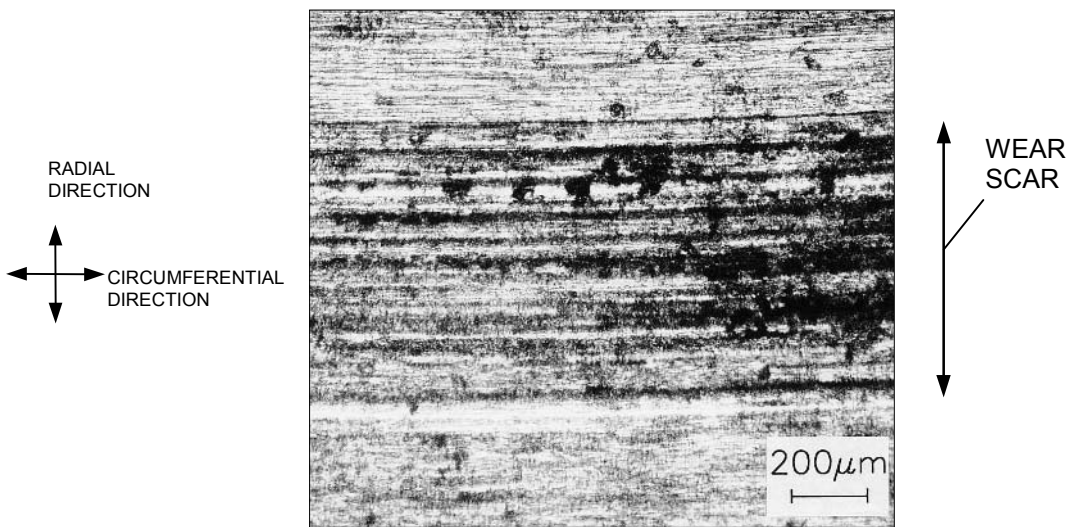
**Fig. 6.2** Valve seating face showing a series of ridges and valleys formed circumferentially around the axis of the valve (valve material V1 run against cast seat insert material S3 on hydraulic loading apparatus). Major seat diameter is towards bottom of figure. See Table 6.1 for details of materials. (Reprinted with permission from SAE paper 1999-01-1216 © 1999 Society of Automotive Engineers, Inc.)

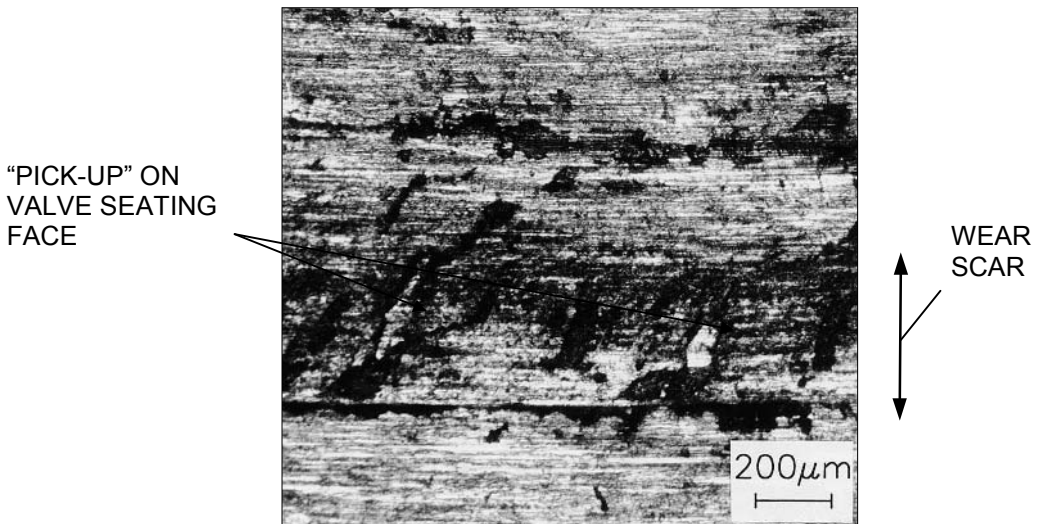
**Fig. 6.3** Valve seating face showing evidence of adhesive pick-up from the seat insert (valve material V1 run against sintered seat insert material S2 on hydraulic loading apparatus). Major seat diameter is towards bottom of figure. See Table 6.1 for details of materials

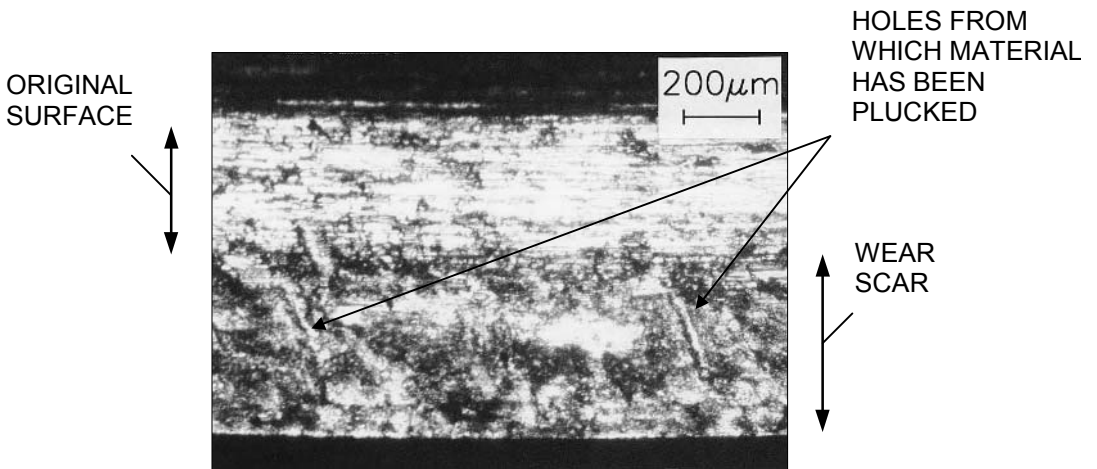
**Fig. 6.4** Seat insert seating face showing evidence of adhesive pick-up (valve material V1 run against sintered seat insert material S2 on hydraulic loading apparatus). Major seat diameter is towards top of figure. See Table 6.1 for details of materials

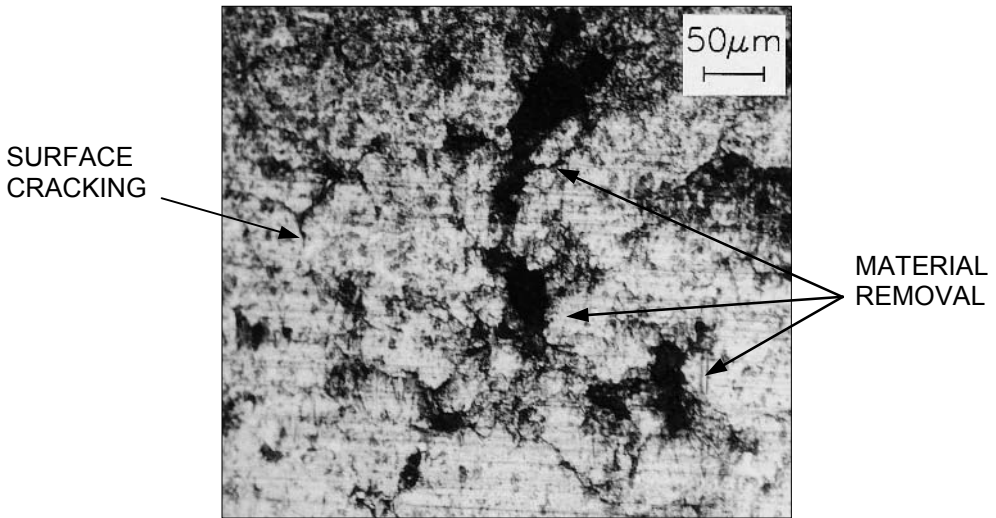
**Fig. 6.5** Seat insert seating face (valve material V1 run against cast seat insert material S3 on motorized cylinder head). Major seat diameter is towards top of figure. See Table 6.1 for details of materials

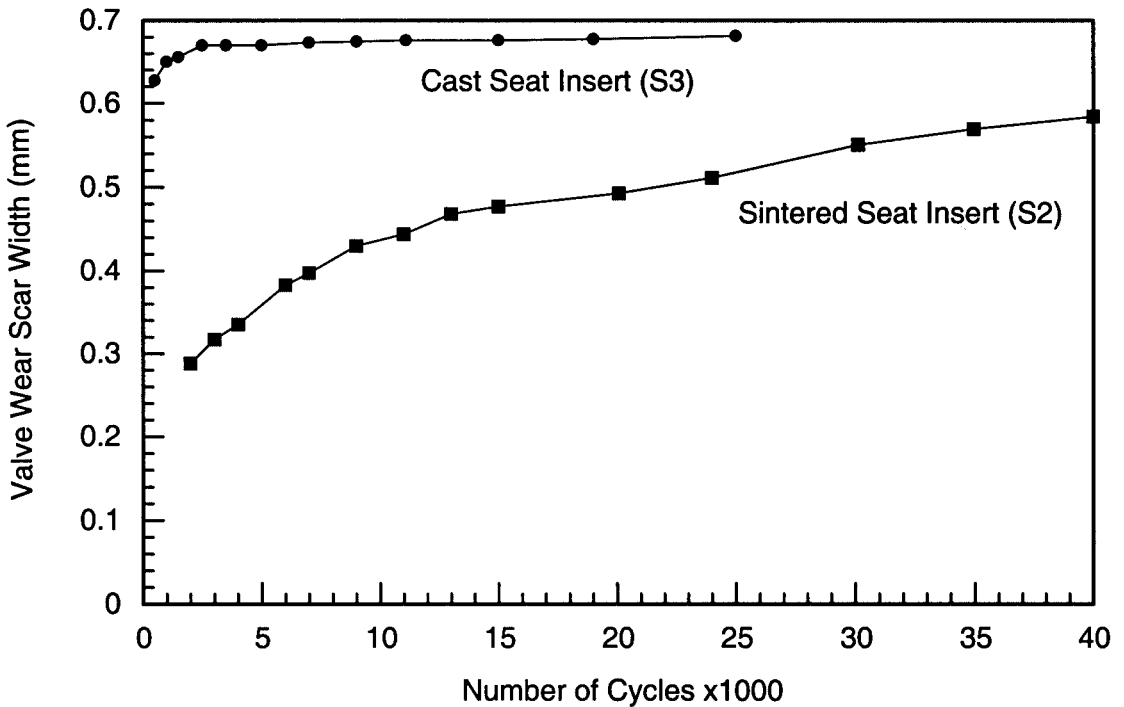
**Fig. 6.7 Average wear scar width for a V1 valve run against an S2 sintered seat insert and a V1 valve run against an S3 cast seat insert using impact and sliding on the hydraulic loading apparatus. See Table 6.1 for details of materials**

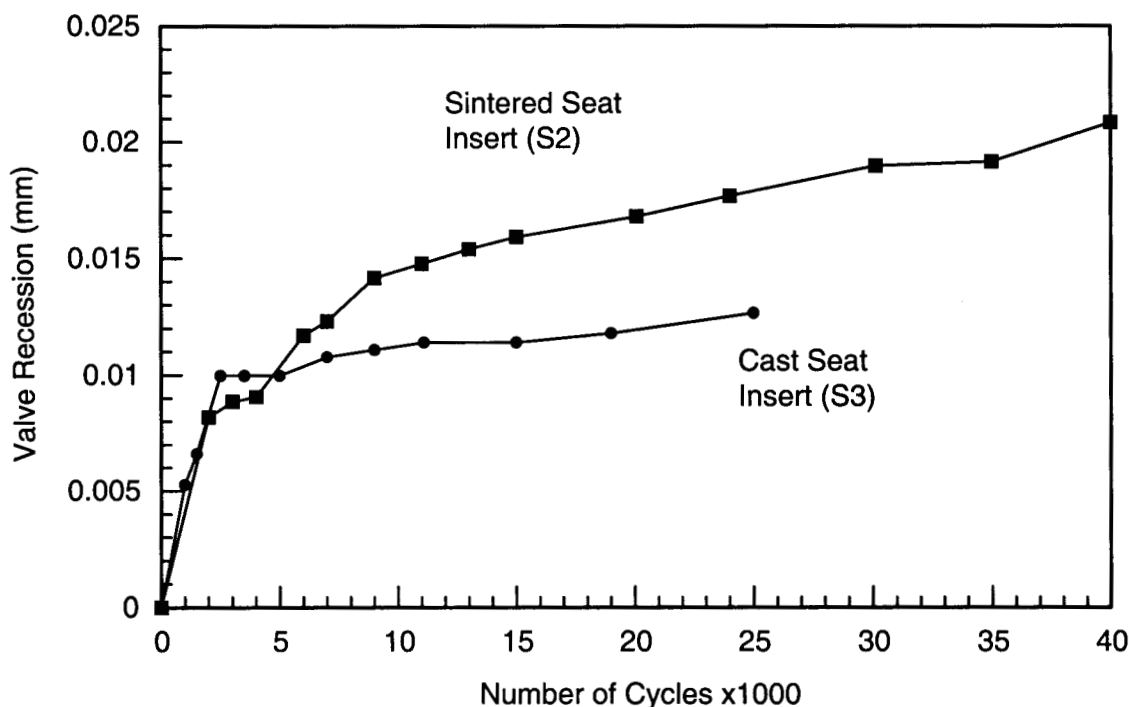
**Fig. 6.8** Valve recession for a V1 valve run against an S2 sintered seat insert and a V1 valve run against an S3 cast seat insert using impact and sliding on the hydraulic loading apparatus. See Table 6.1 for details of materials

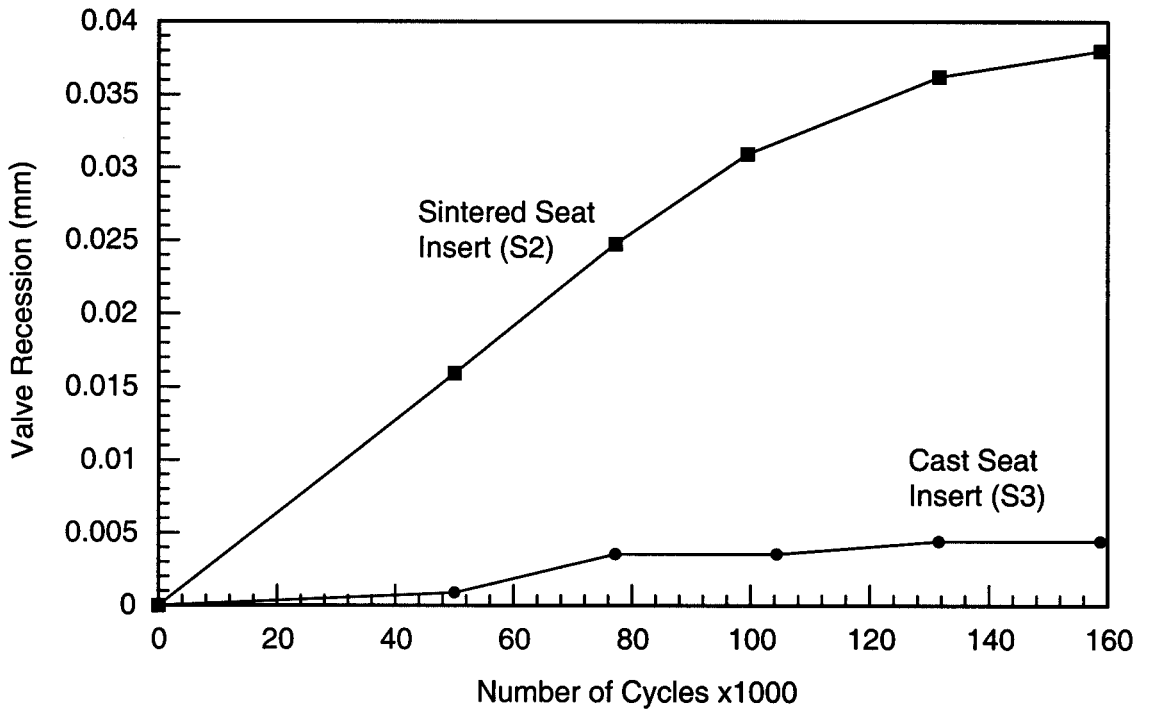
**Fig. 6.9** Valve recession for a V1 valve run against an S2 sintered seat insert and a V1 valve run against an S3 cast seat insert with a valve closing velocity of 960 mm/s on the motorized cylinder head. See Table 6.1 for details of materials

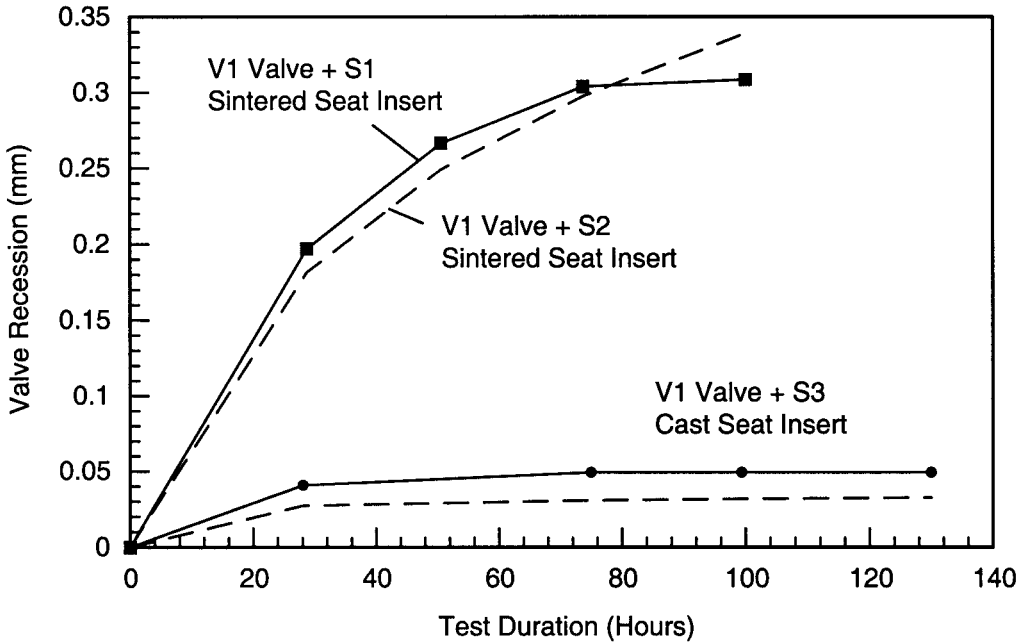
**Fig. 6.11 Comparison of hydraulic loading apparatus results with engine test data (solid line – engine test data; broken line – extrapolated test rig data. See Table 6.1 for details of materials**

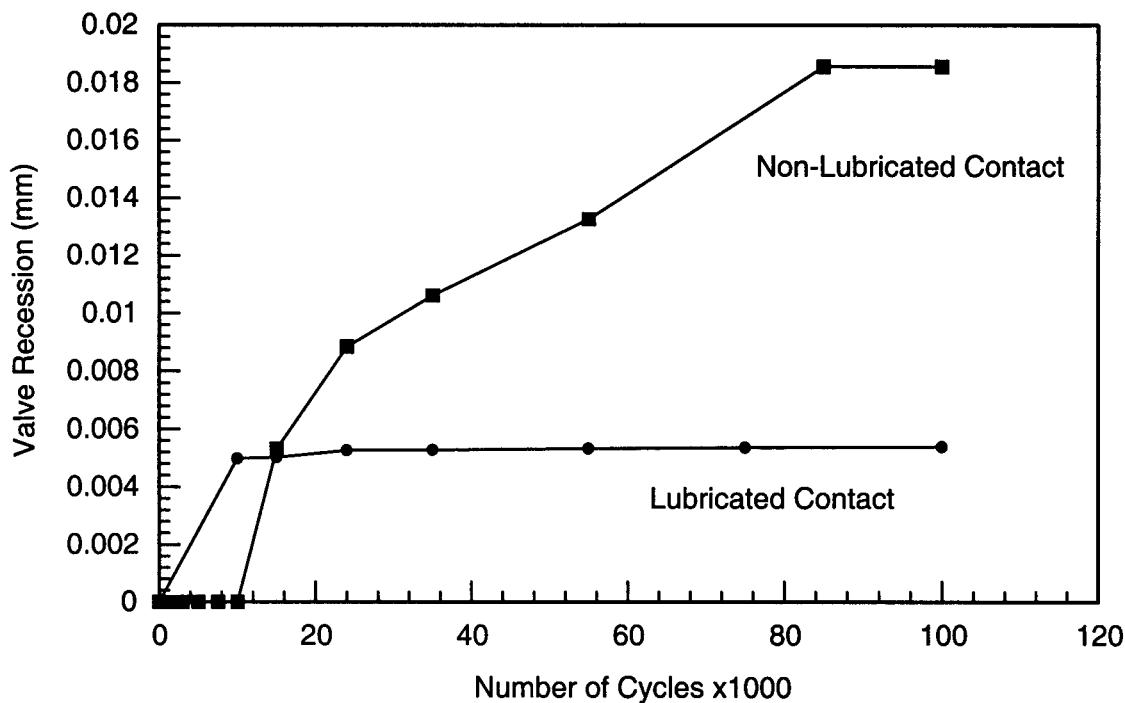
**Fig. 6.12** Valve recession for V1 valves run lubricated and unlubricated against an S3 cast seat insert using impact and sliding on the hydraulic loading apparatus. See Table 6.1 for details of materials

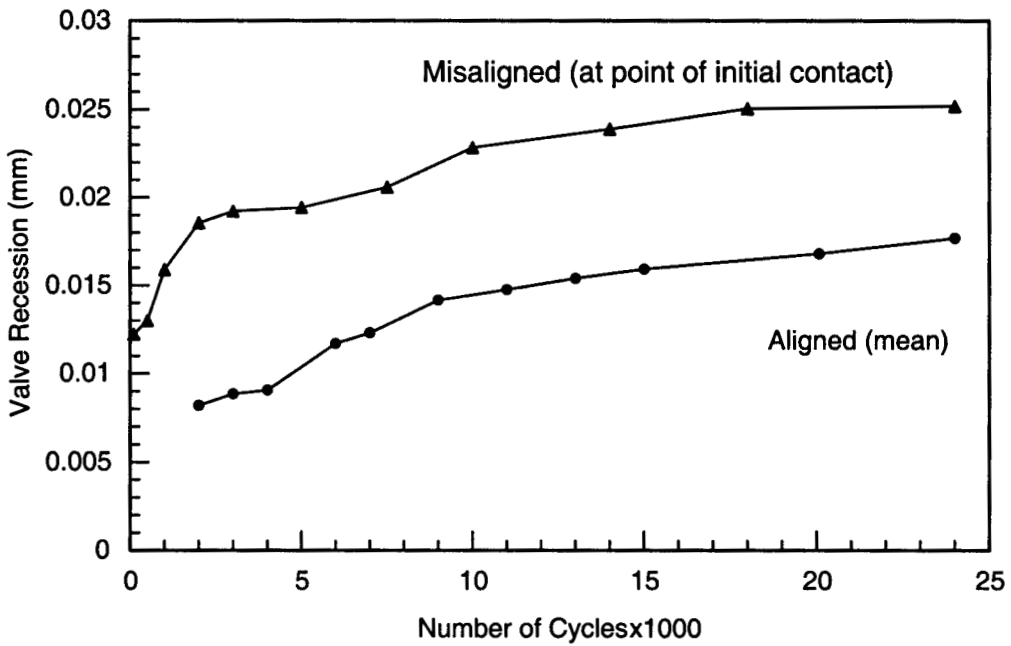
**Fig. 6.15** Valve wear scar width for a V1 valve run aligned and misaligned against an S2 sintered seat insert using impact and sliding on the hydraulic loading apparatus. See Table 6.1 for details of materials

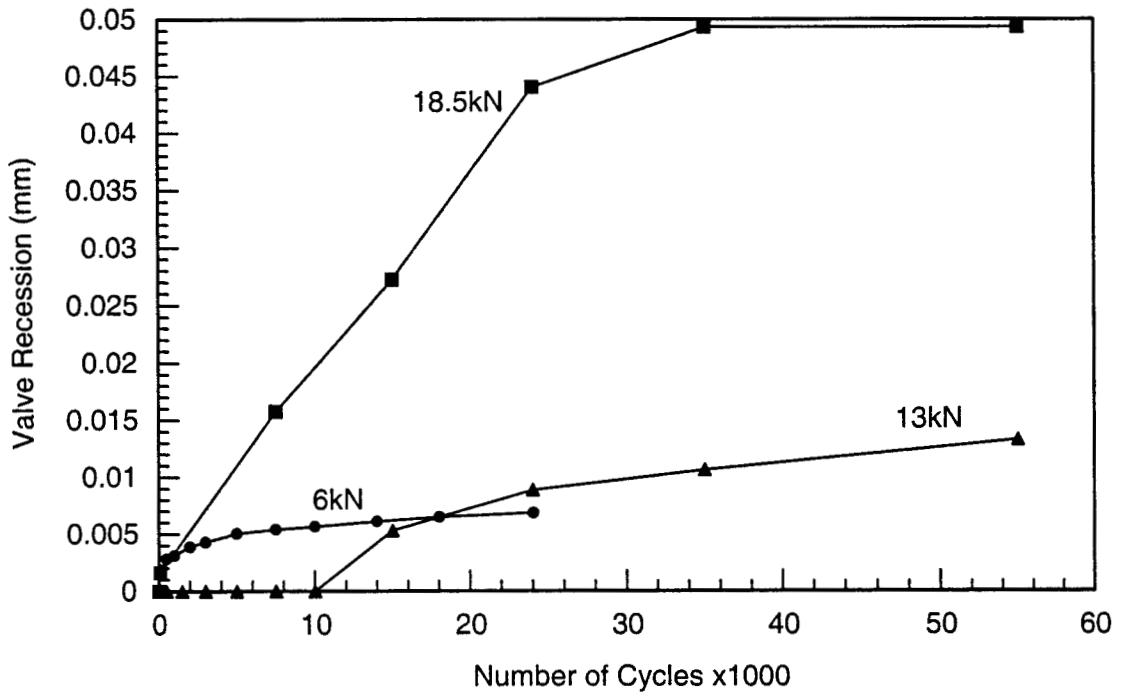
**Fig. 6.16** Valve recession for V1 valves run at three different combustion loads against S3 cast seat inserts using impact and sliding on the hydraulic loading apparatus. See Table 6.1 for details of materials

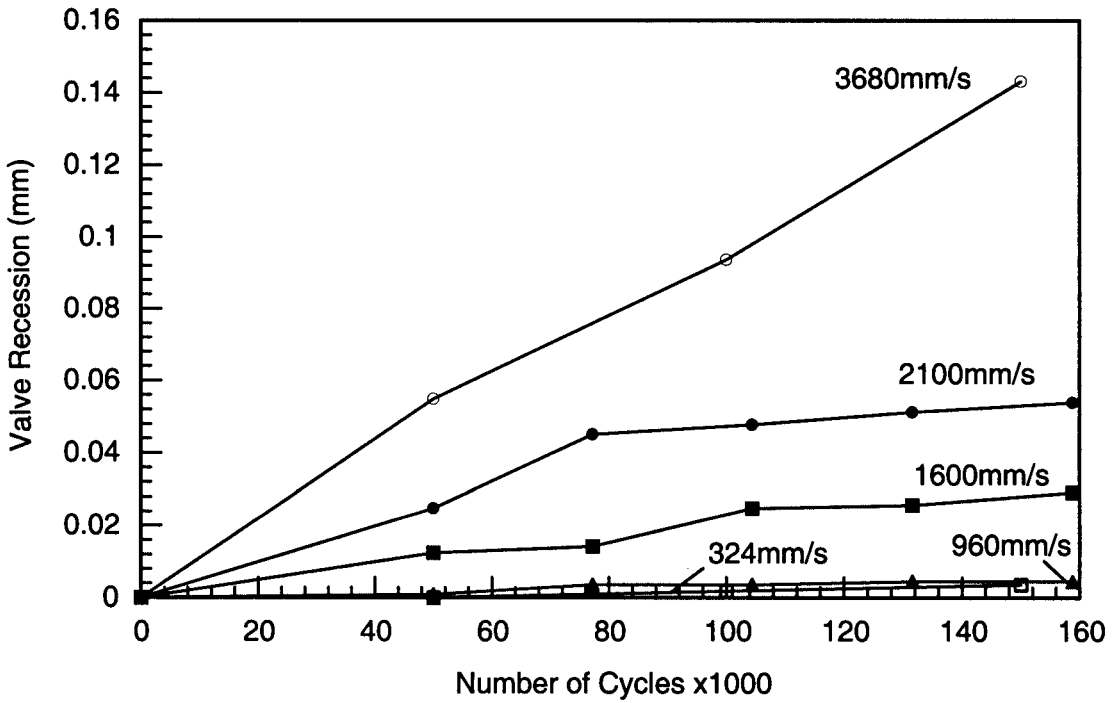
Fig. 6.17 Valve recession for V1 valves run with different closing velocities against S3 cast seat inserts on the motorized cylinder head. See Table 6.1 for details of materials

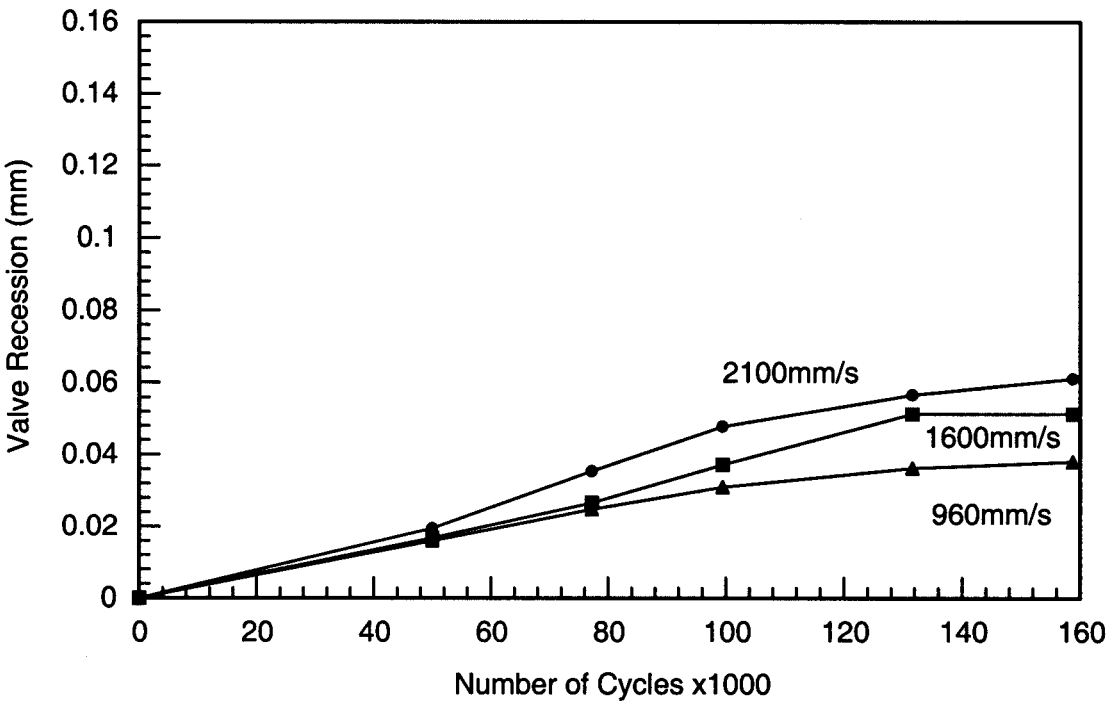
Fig. 6.18 Valve recession for V1 valves run with different closing velocities against S2 sintered seat inserts on the motorized cylinder head. See Table 6.1 for details of materials

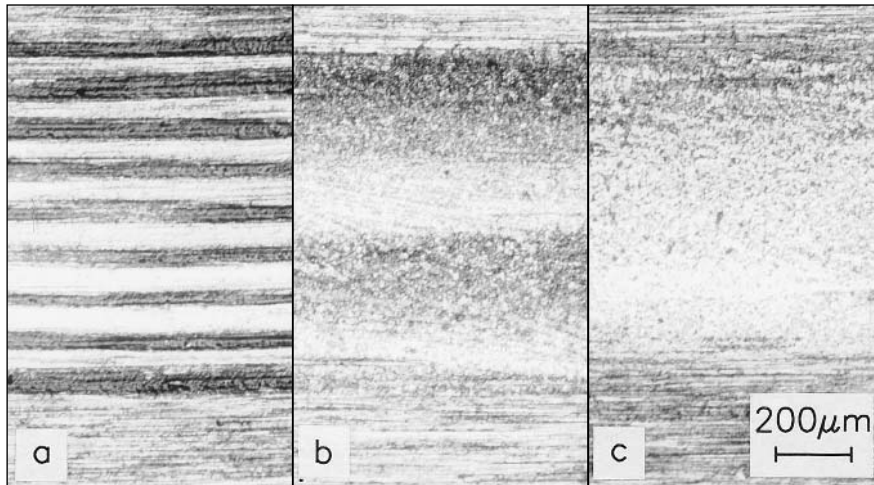
**Fig 6.19 Seating faces of valves run with closing velocities of: (a) 960 mm/s; (b) 1600 mm/s; (c) 2100 mm/s. Valve material V1 run against cast seat insert material S3 on motorized cylinder-head. Major seat diameter is towards bottom of figure. See Table 6.1 for details of materials**

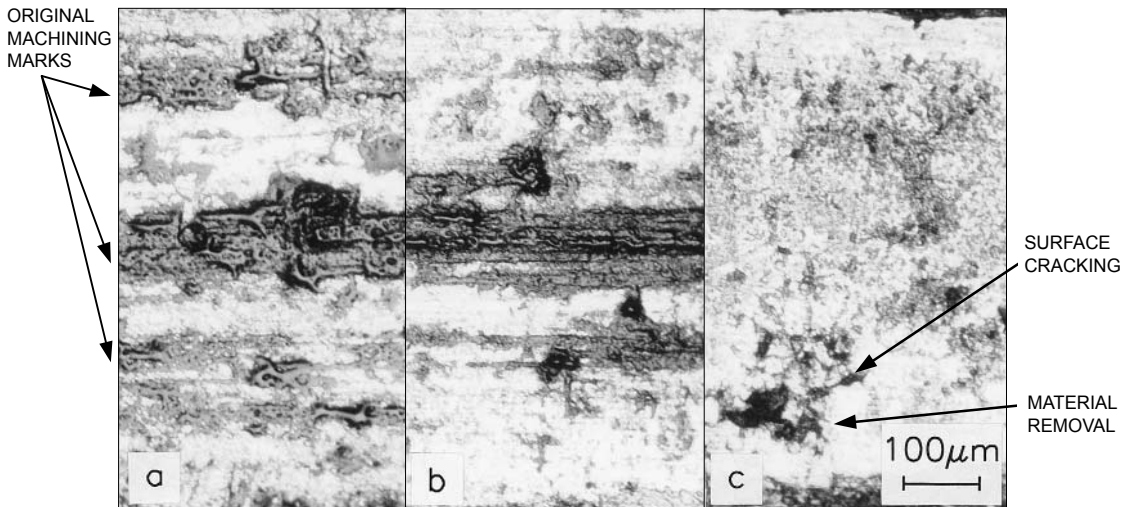
**Fig. 6.20** Seating faces of seat inserts run against valves with closing velocities of: (a) 960 mm/s; (b) 1600 mm/s; (c) 2100 mm/s. Valve material V1 run against cast seat insert material S3 on motorized cylinder head. Major seat diameter is towards top of figure. See Table 6.1 for details of materials

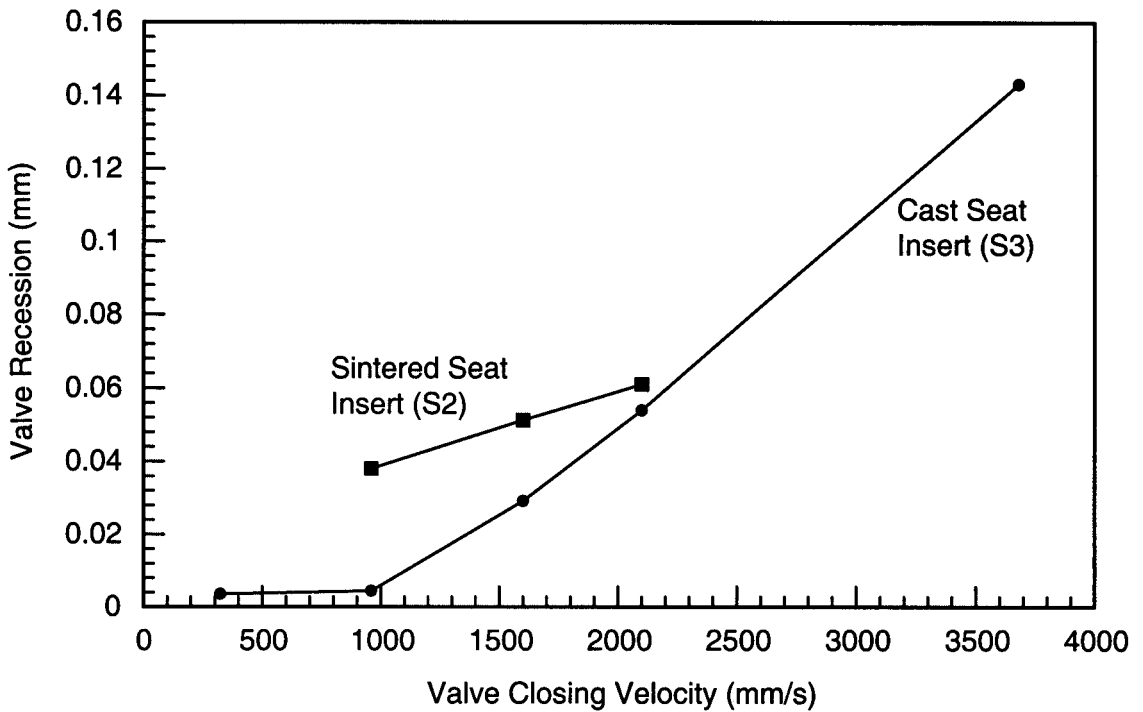
**Fig. 6.21** Valve recession against closing velocity for a V1 valve run against an S2 sintered seat insert and a V1 valve run against an S3 cast seat insert on the motorized cylinder head (at 160 000 cycles). See Table 6.1 for details of materials

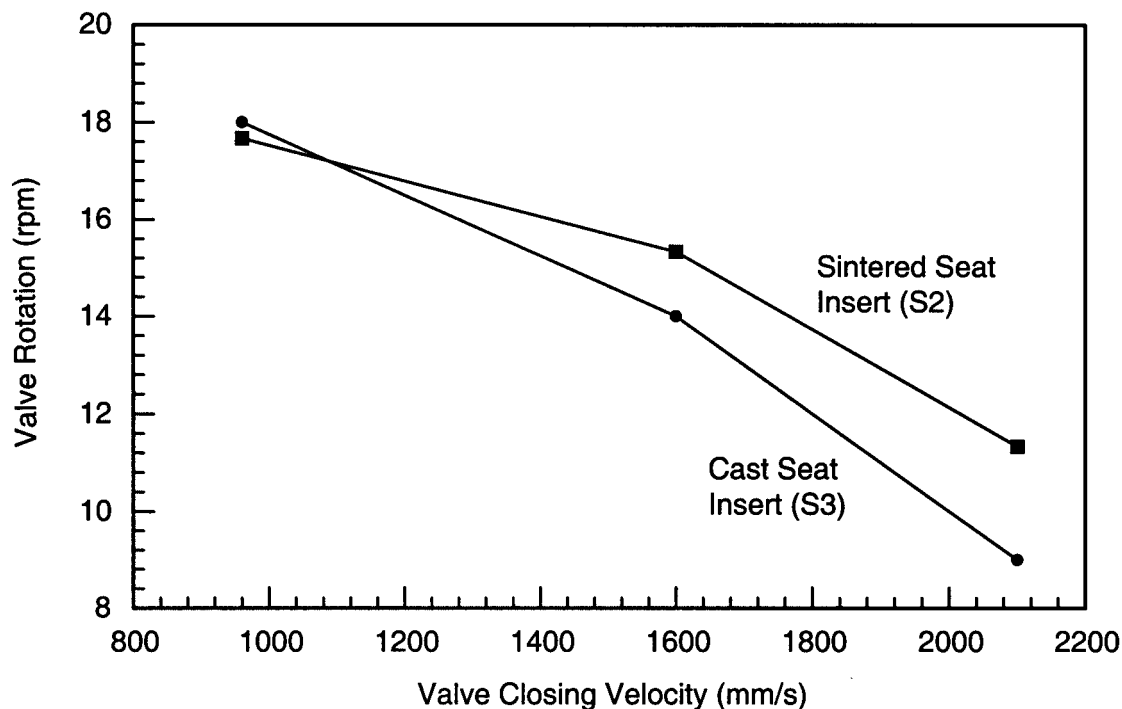
**Fig. 6.23** Valve rotation against valve closing velocity for a V1 valve run against an S2 sintered seat insert and a V1 valve run against an S3 cast seat insert on the motorized cylinder head. See Table 6.1 for details of materials

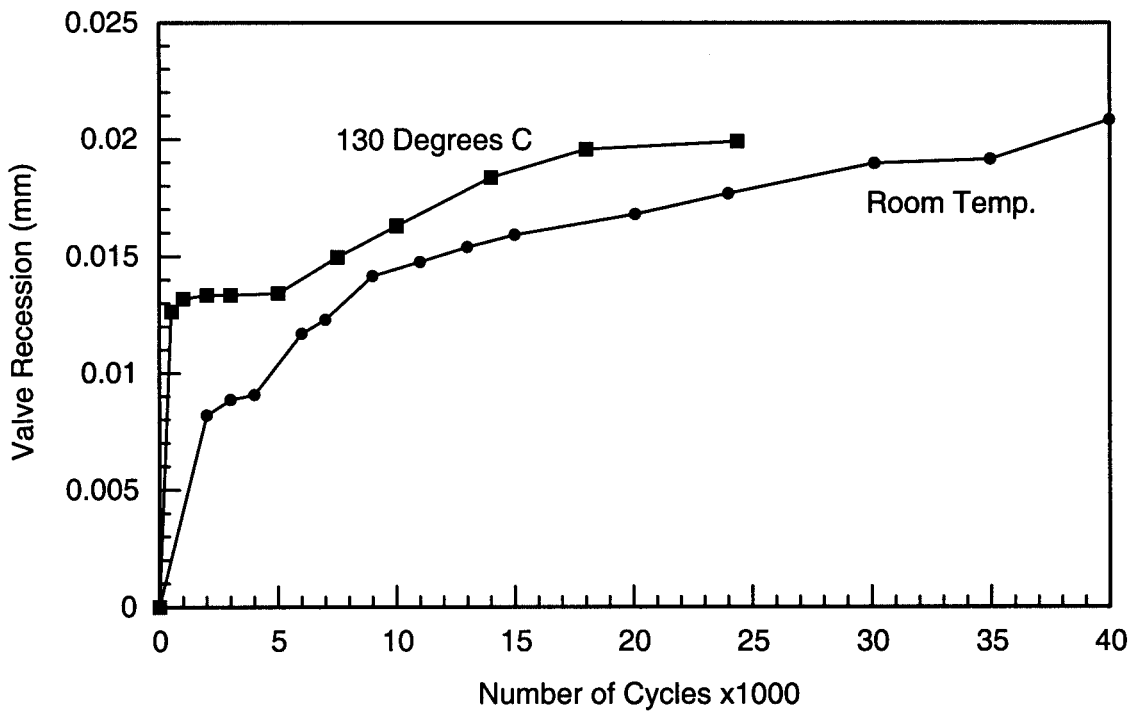
**Fig. 6.24** Valve recession for V1 valves run at two different temperatures against S2 sintered seat inserts using impact and sliding on the hydraulic loading apparatus. See Table 6.1 for details of materials

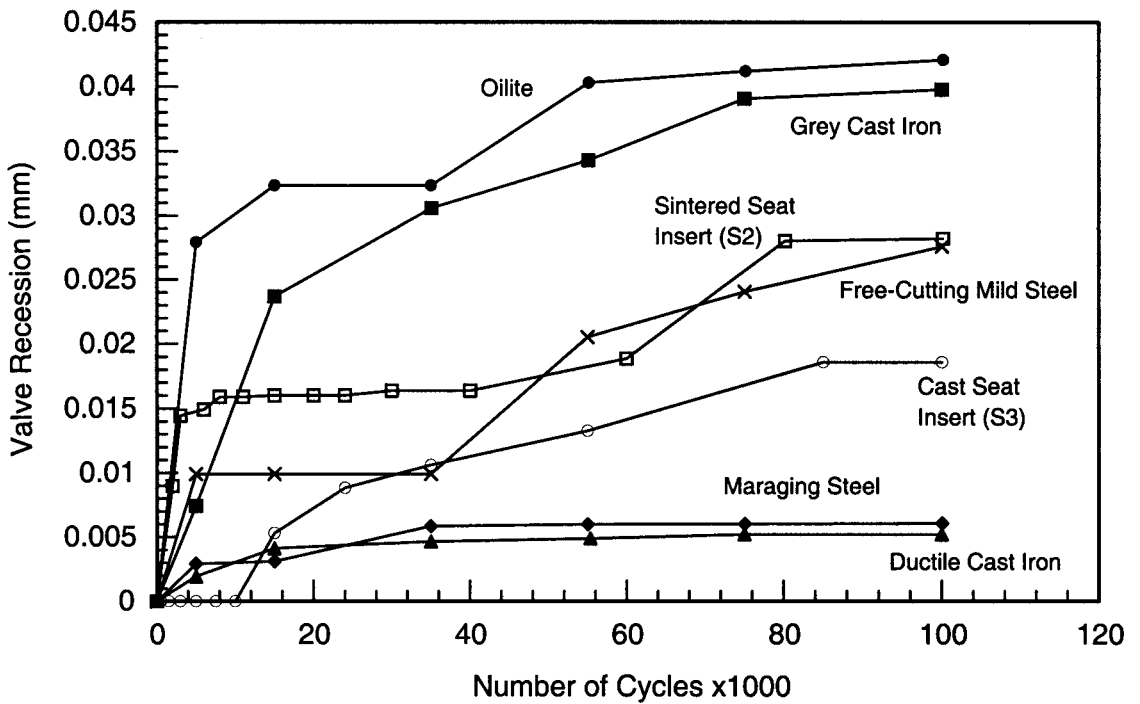
**Fig. 6.25 Valve recession for V1 valves run against various seat materials using impact and sliding on the hydraulic loading apparatus**

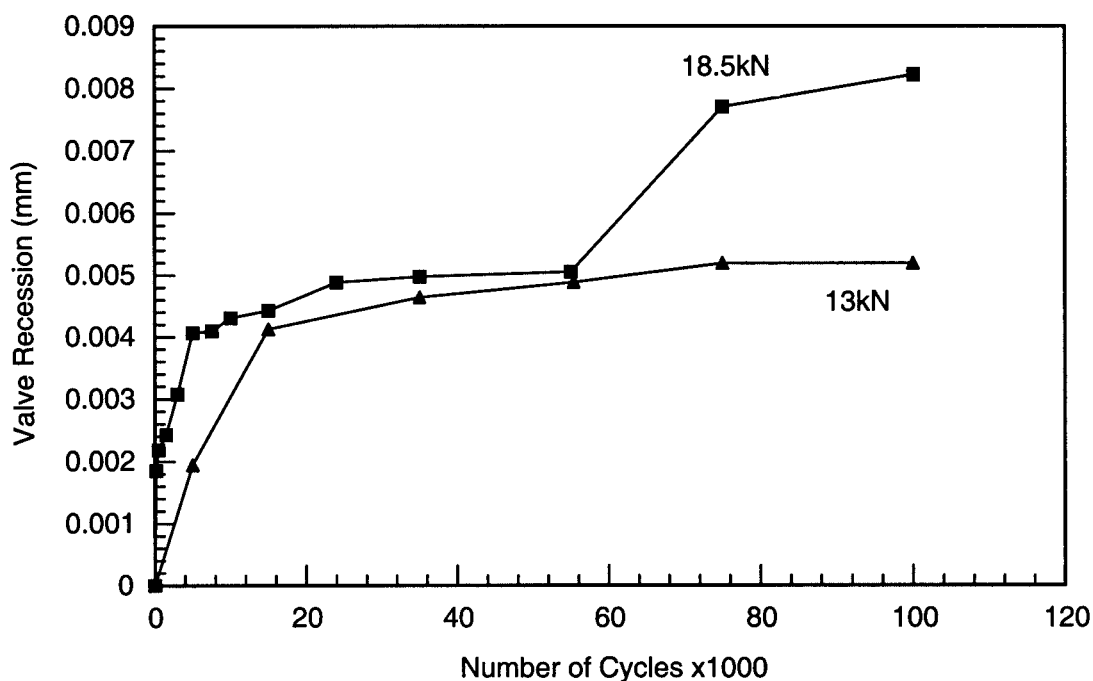
**Fig. 6.26** Valve recession for V1 valves run at two different combustion loads against ductile cast iron seats using impact and sliding on the hydraulic loading apparatus

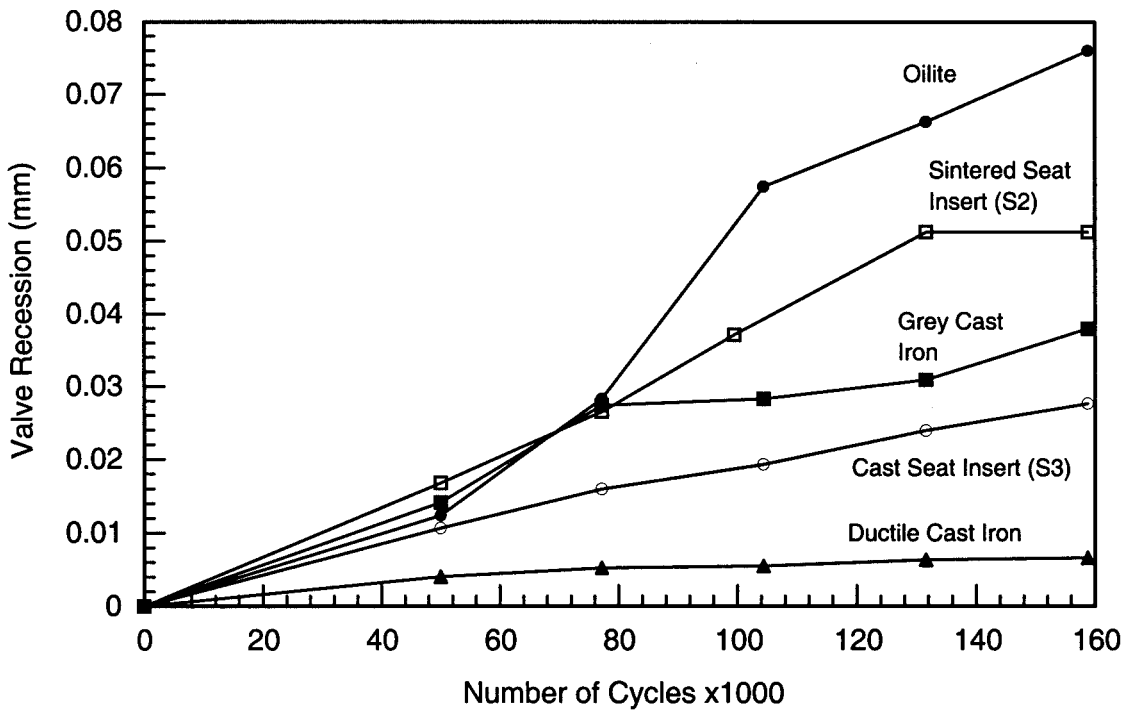
**Fig. 6.27** Valve recession for V1 valves run against various seat materials with a valve closing velocity of 1600 mm/s on the motorized cylinder head

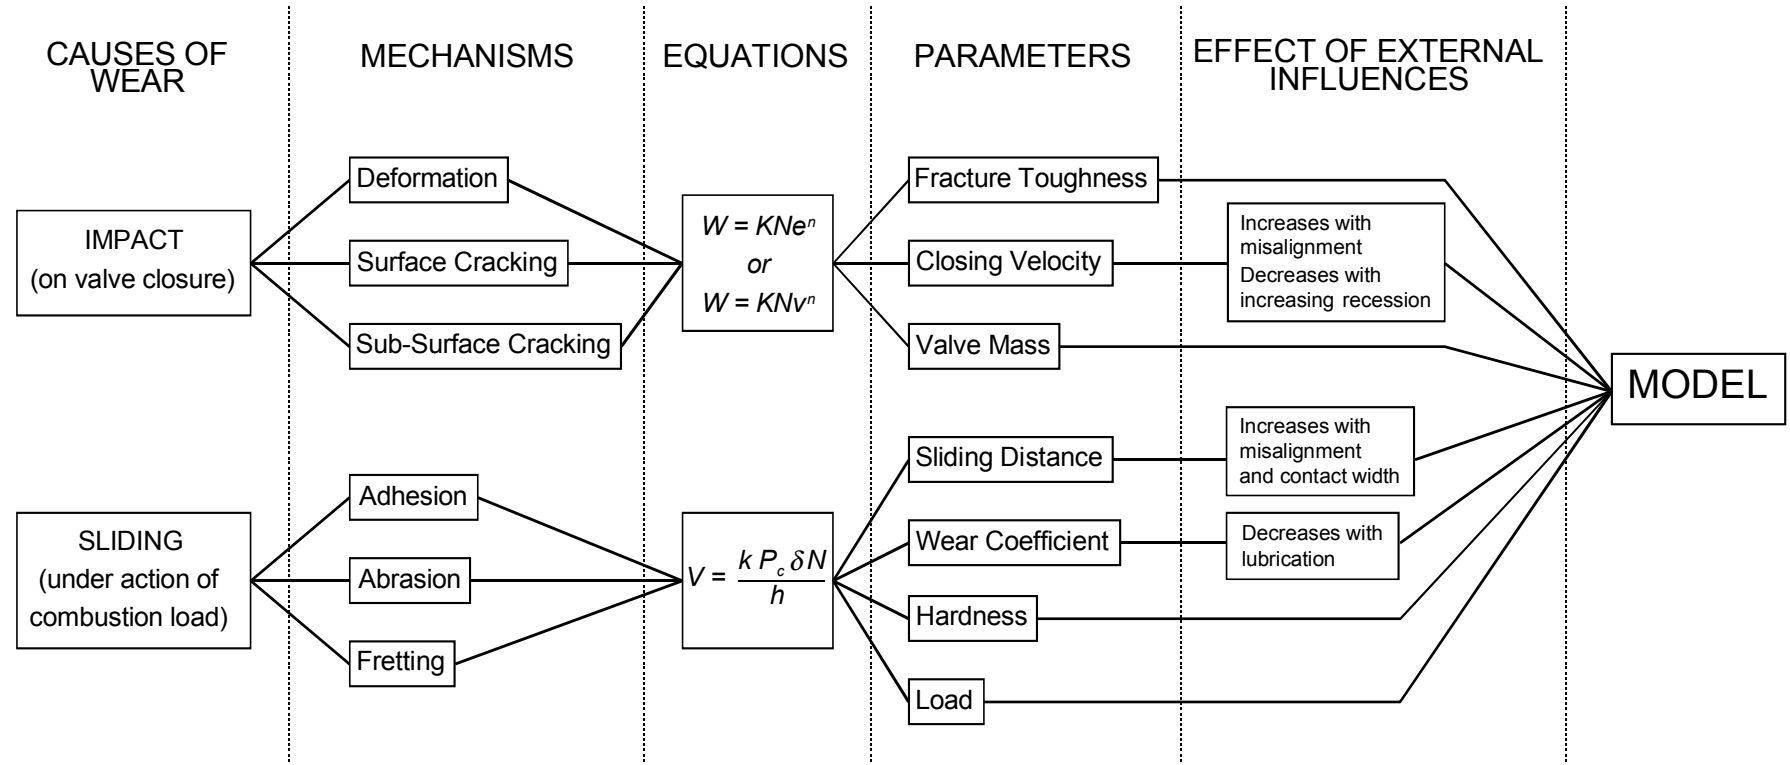
**Fig. 7.2 Development of the valve recession model**

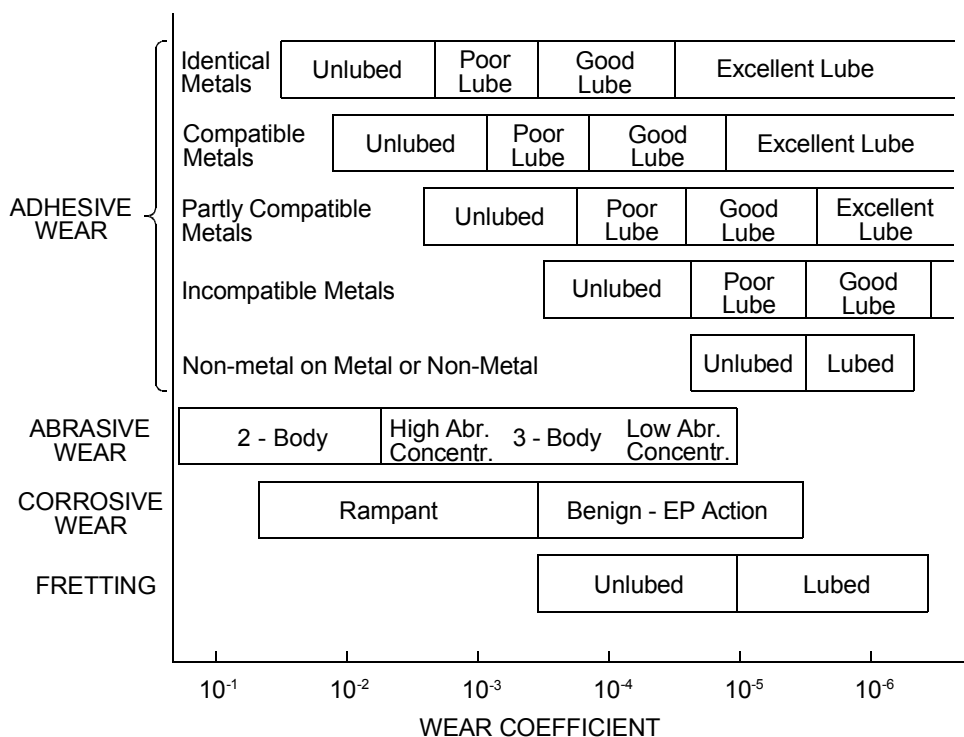
Fig. 7.4 Wear coefficients to be anticipated in various sliding situations [7]

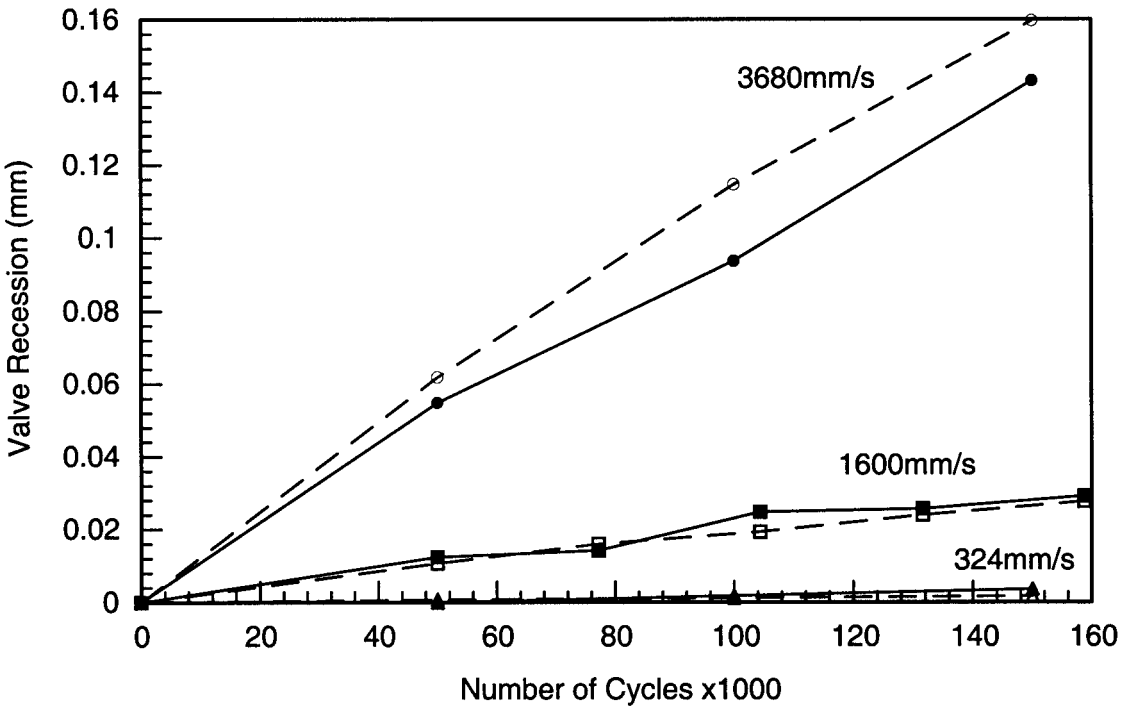
**Fig. 7.5 Modelling of valve recession for V1 valves run with three different closing velocities against S3 cast seat inserts on the motorized cylinder head (solid line – experimental data; broken line – model prediction)**
