# Automotive Engine Valve Recession

R Lewis and R S Dwyer-Joyce

Professional Engineering Publishing Limited,  
London and Bury St Edmunds, UK

First published 2002

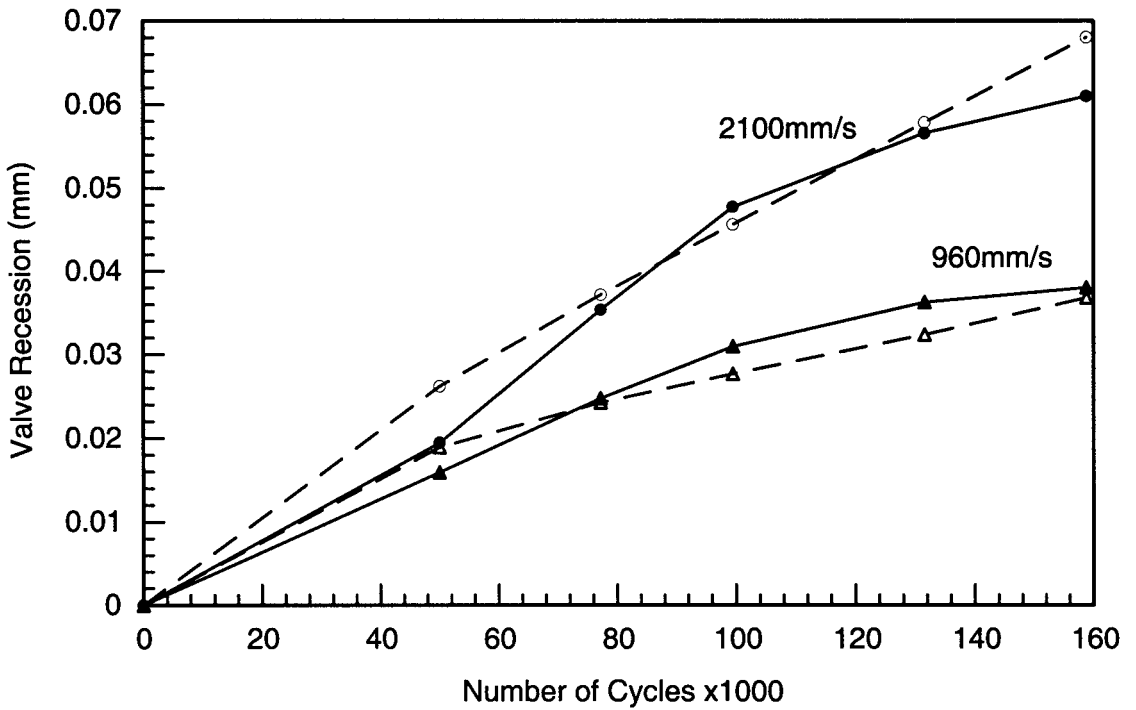
Fig. 7.6 Modelling of valve recession for V1 valves run with two different closing velocities against S2 sintered seat inserts on the motorized cylinder head (solid line – experimental data; broken line – model prediction)

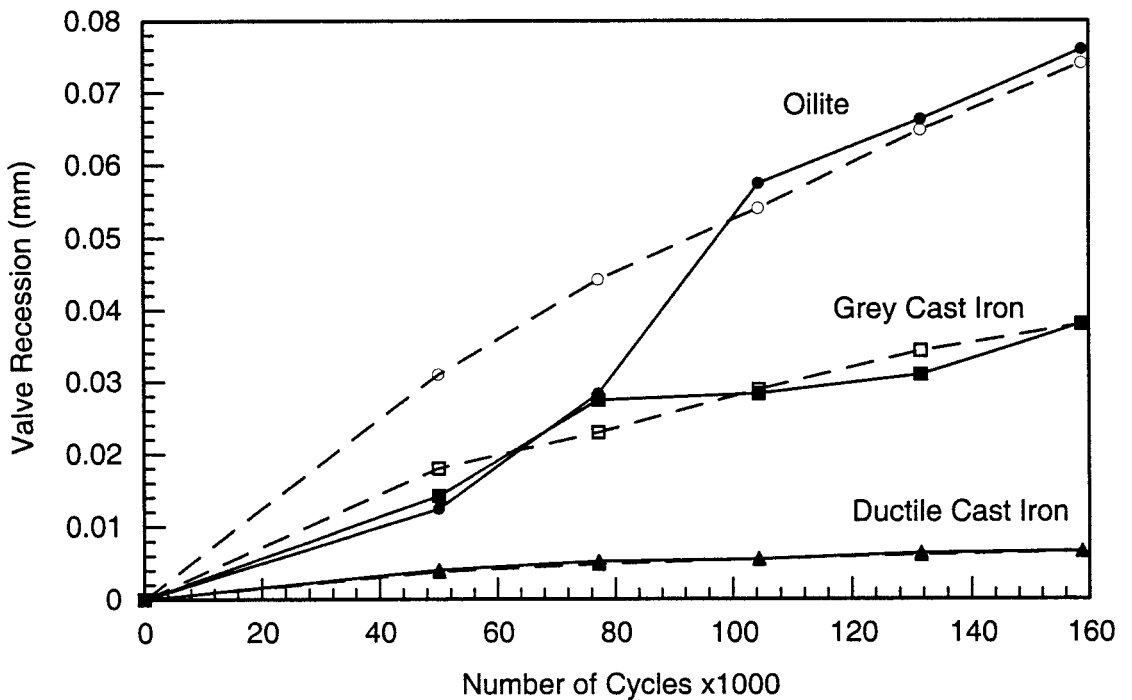
Fig. 7.7 Modelling of valve recession for V1 valves run against various seat materials with a closing velocity of 1600 mm/s on the motorized cylinder head (solid line – experimental data; broken line – model prediction)

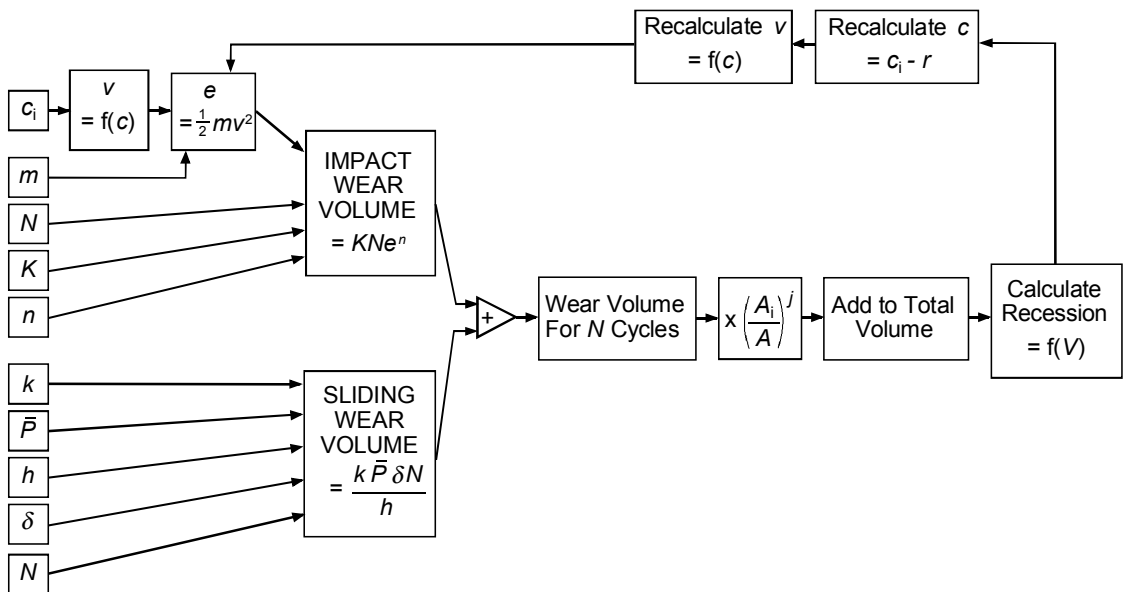
**Fig. 7.8 Valve recession model application flow chart (Reprinted with permission from SAE paper 2001-01-1987 © 2001 Society of Automotive Engineers, Inc.)**

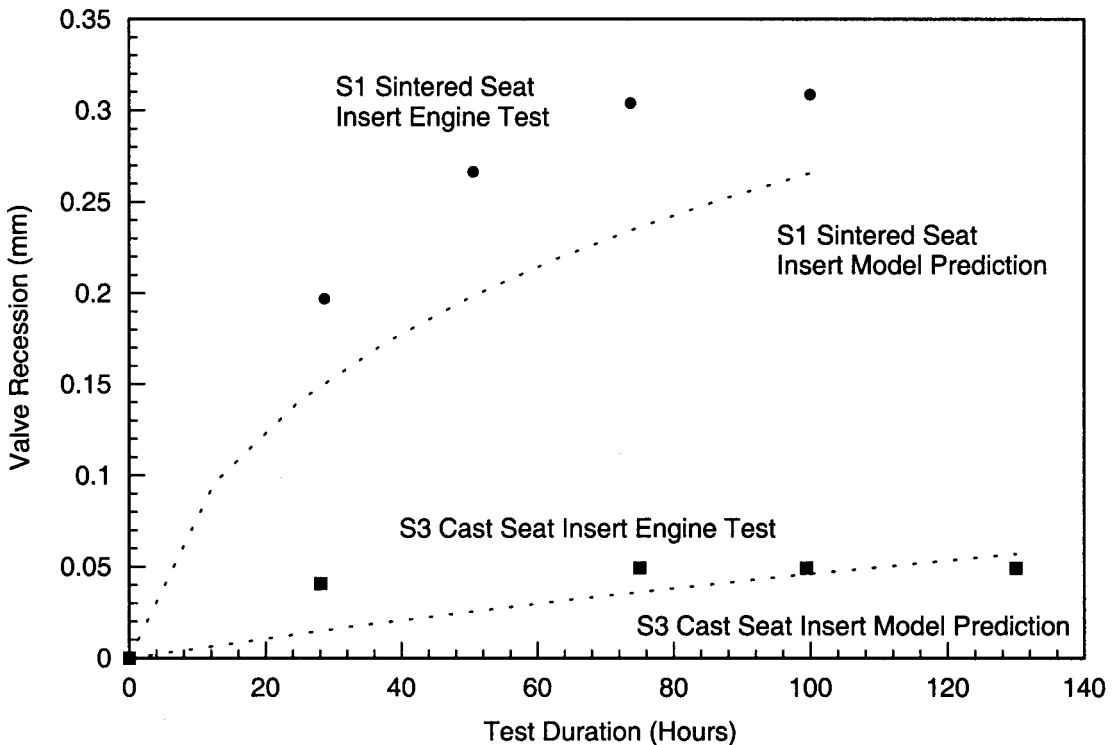
Fig. 7.12 Model prediction (broken line) versus engine test data. (Reprinted with permission from SAE paper 2001-01-1987 © 2001 Society of Automotive Engineers, Inc.)

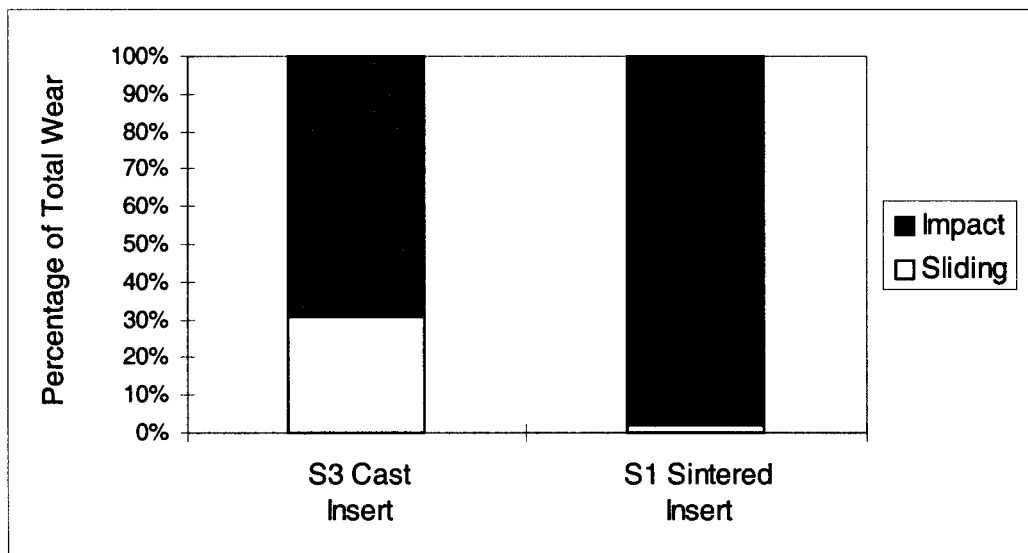
**Fig. 7.13 Percentage of total wear caused by impact and sliding for a cast seat insert (S3) engine test**

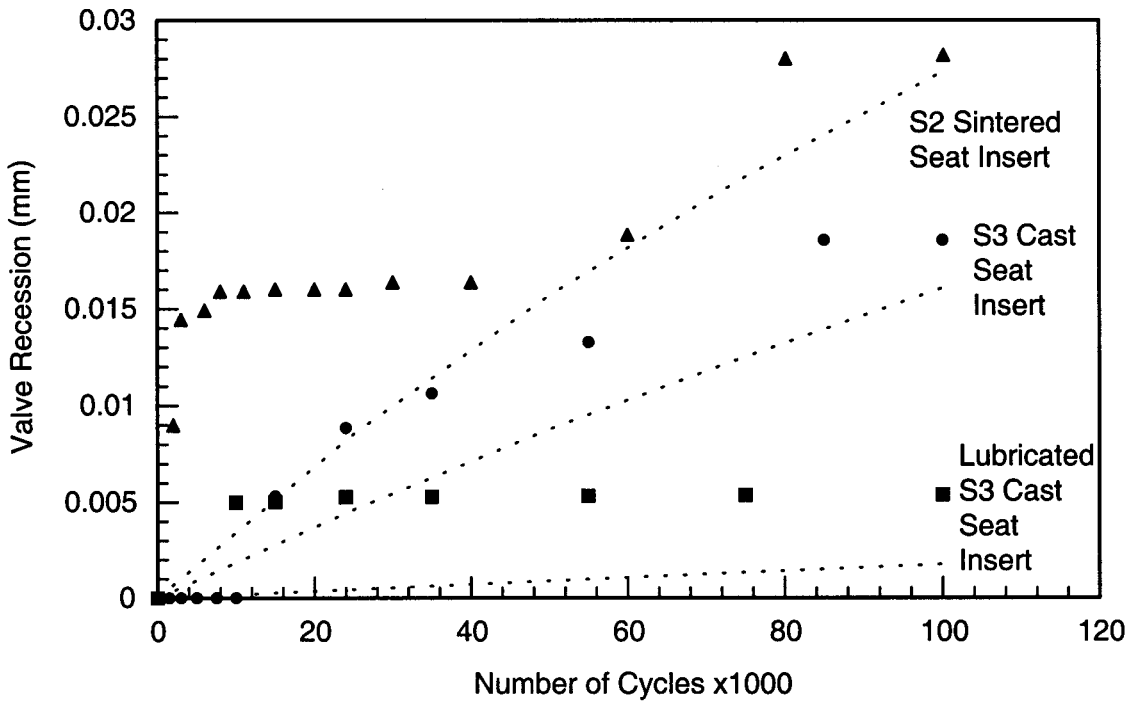
Fig. 7.14 Model prediction (broken lines) versus hydraulic loading apparatus data for a cast seat insert (S3), sintered seat insert (S2), and a lubricated cast seat insert (S3). (Reprinted with permission from SAE paper 2001-01-1987 © 2001 Society of Automotive Engineers, Inc.)

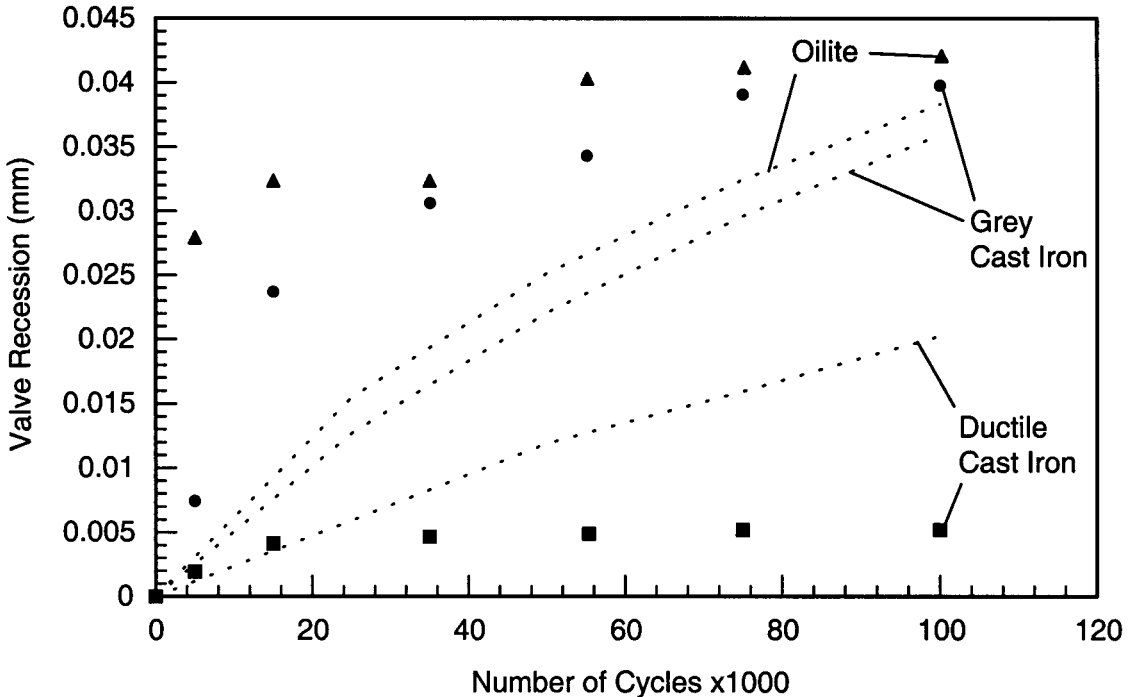
Fig. 7.15 Model prediction (broken line) versus hydraulic loading apparatus data for grey cast iron, ductile cast iron, and oilite seats. (Reprinted with permission from SAE paper 2001-01-1987 © 2001 Society of Automotive Engineers, Inc.)

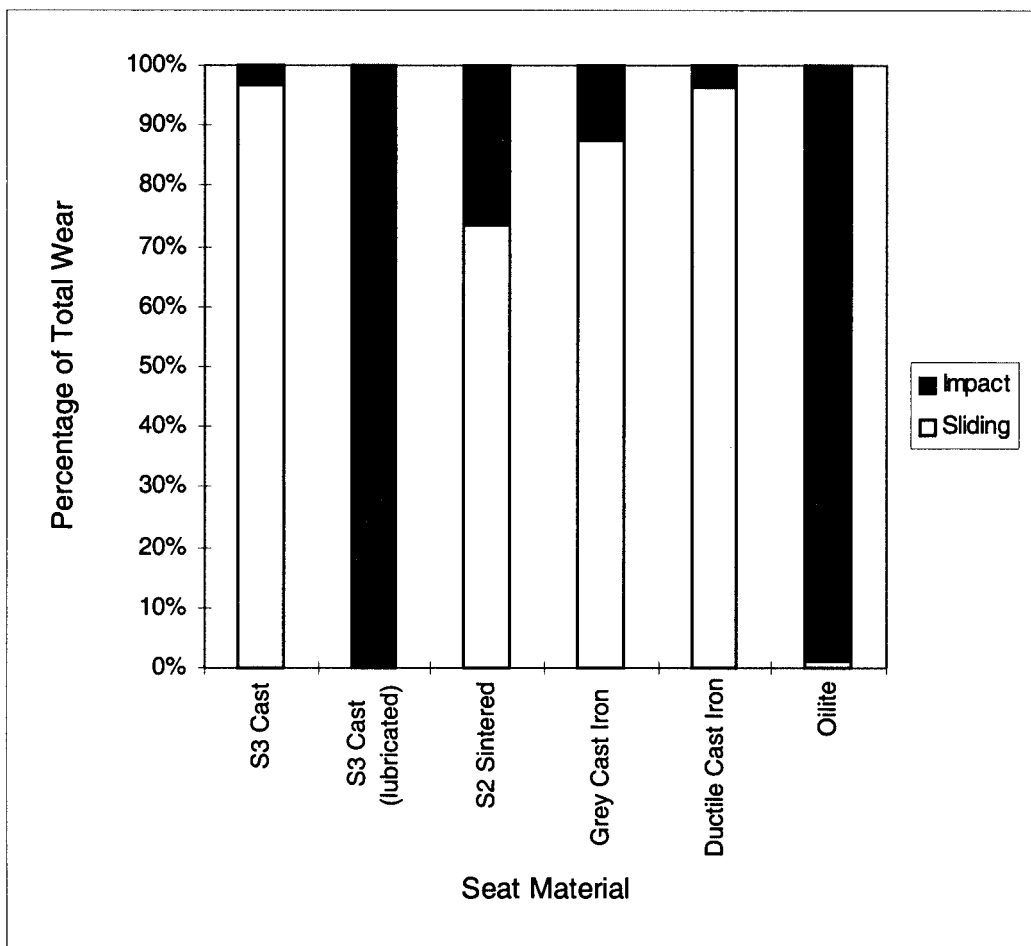
**Fig. 7.16 Percentage of total wear caused by impact and sliding for each bench test modelled**

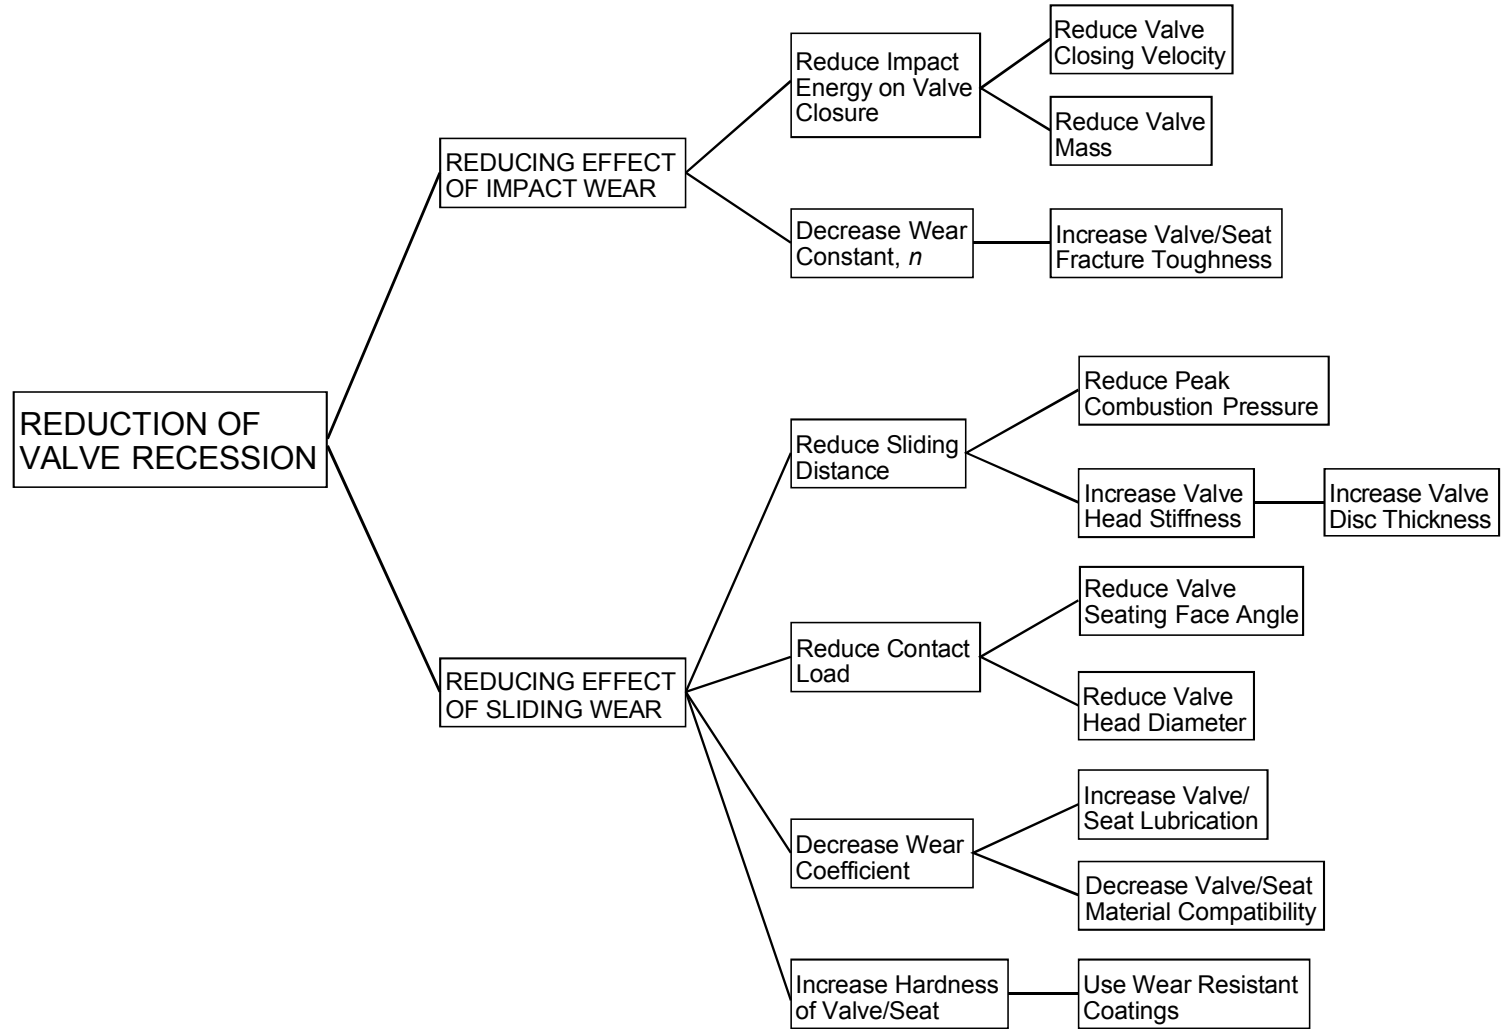
**Fig. 7.17 Reducing valve recession by design.**  
 (Reprinted with permission from SAE paper 2001-01-1987 © 2001 Society of Automotive Engineers, Inc.)

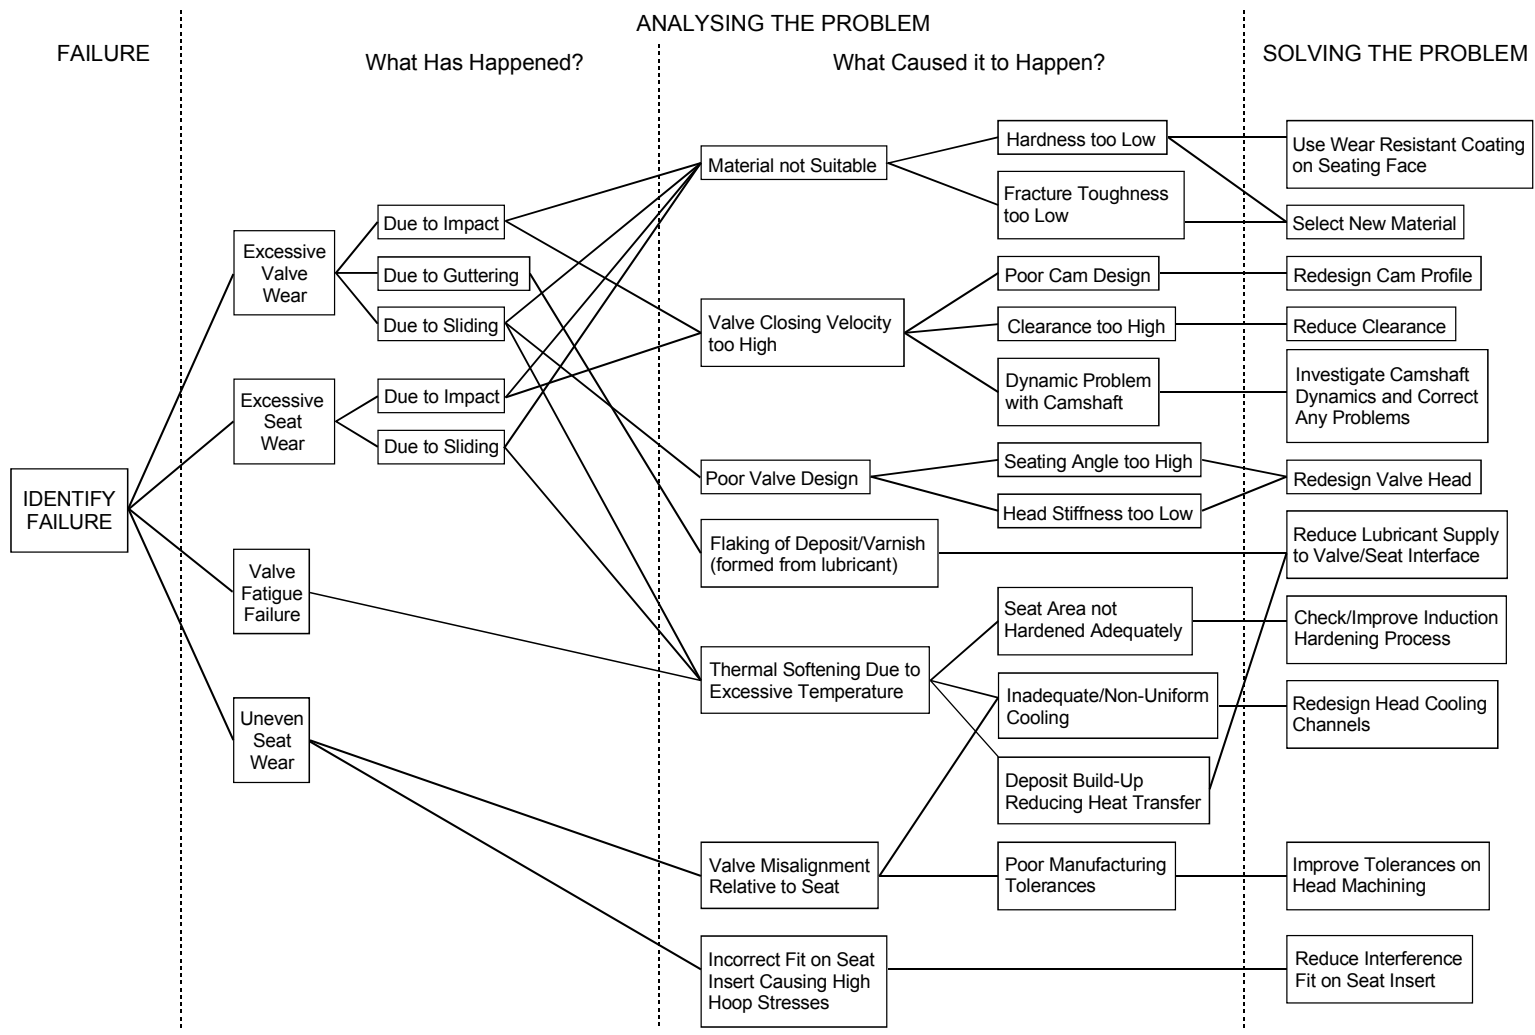
**Fig. 7.18 Solving valve/seat failure problems.**
